Crossing ID: WC_0330

NSWA Sturgeon River Watercourse Assessment

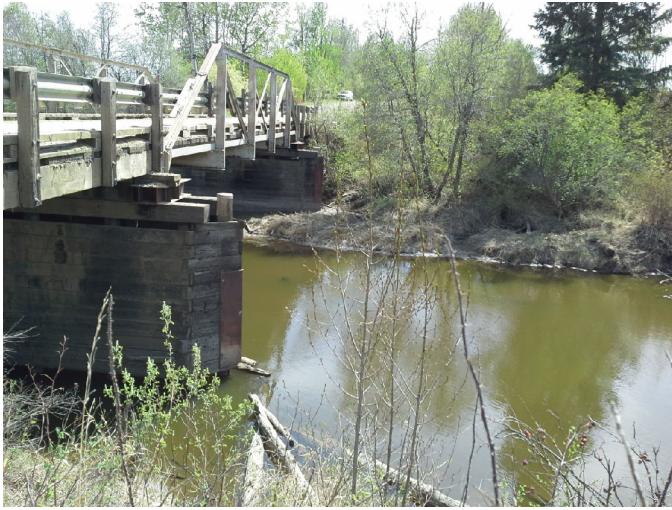
Photo No.: Photos-20180514-212410.jpg
Description: Inlet

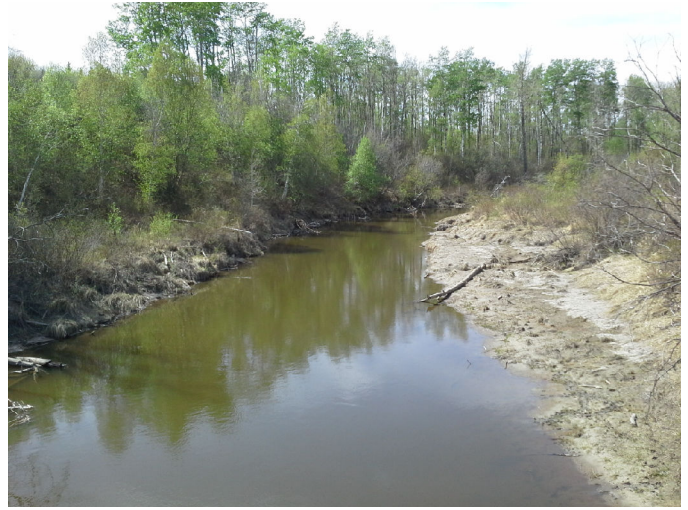
Photo No.: Photos-20180514-212444.jpg
Description: Upstream

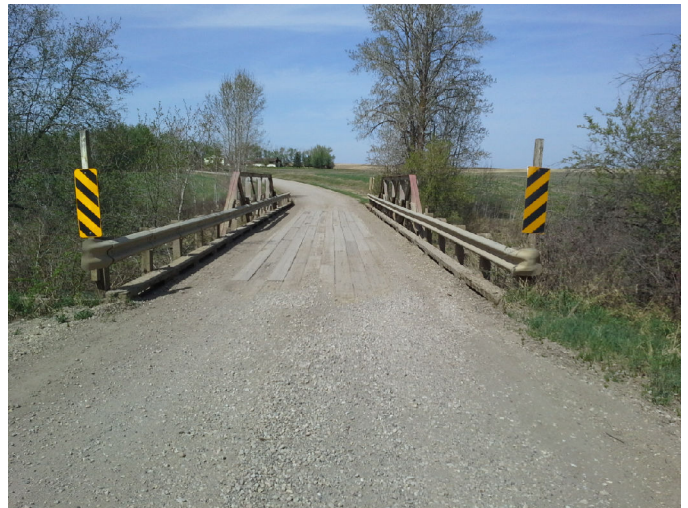
Photo No.: Photos-20180514-212529.jpg
Description: Deck

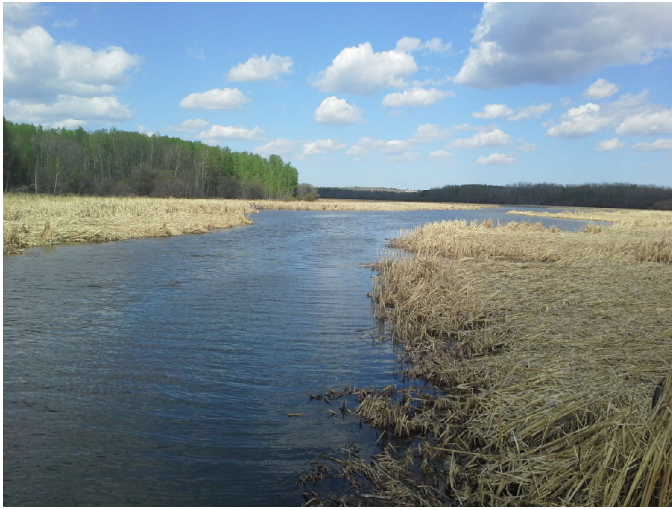
Photo No.: Photos-20180511-212631.jpg
Description: Downstream

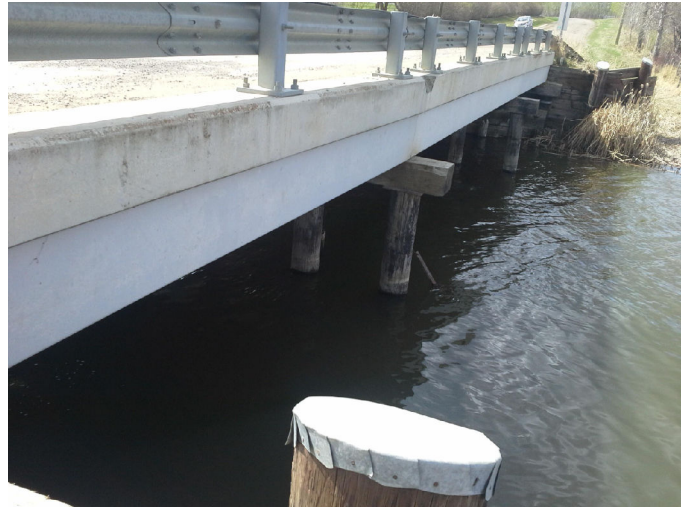
Photo No.: Photos-20180511-212647.jpg
Description: Outlet

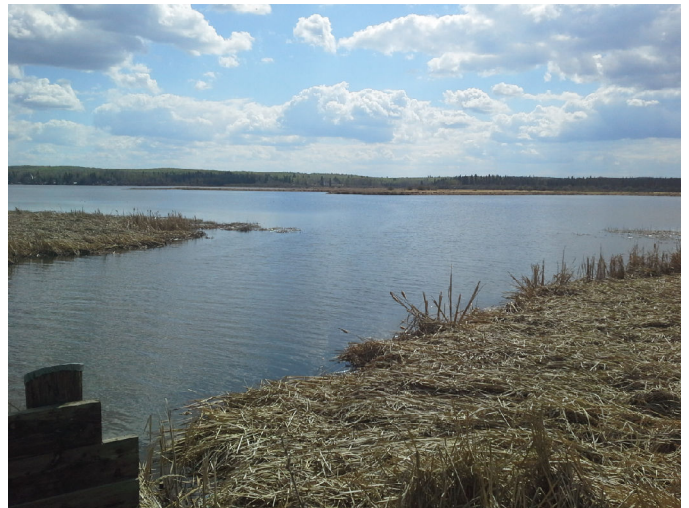
Photo No.: Photos-20180511-212902.jpg
Description: Upstream

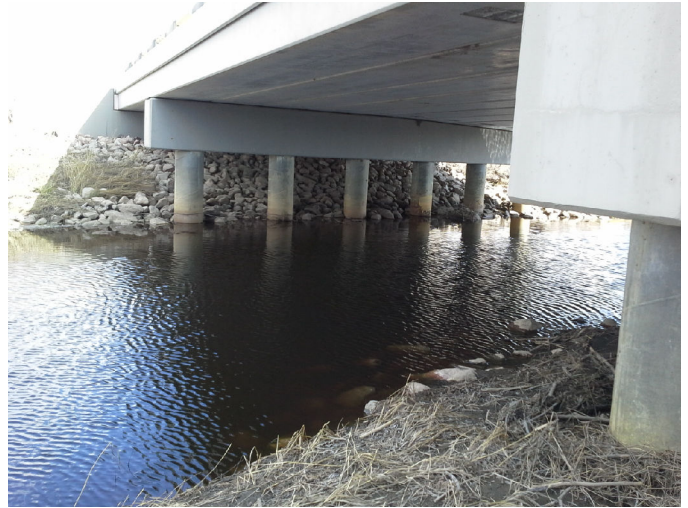
Photo No.: Photos-20180508-213901.jpg
Description: Inlet

Erosion at Site: Yes **Erosion Location (Inlet or Outlet):** Both

Erosion Source: Fill Slope

Erosion Extent: Low **Total Erosion Area:** 18 m²

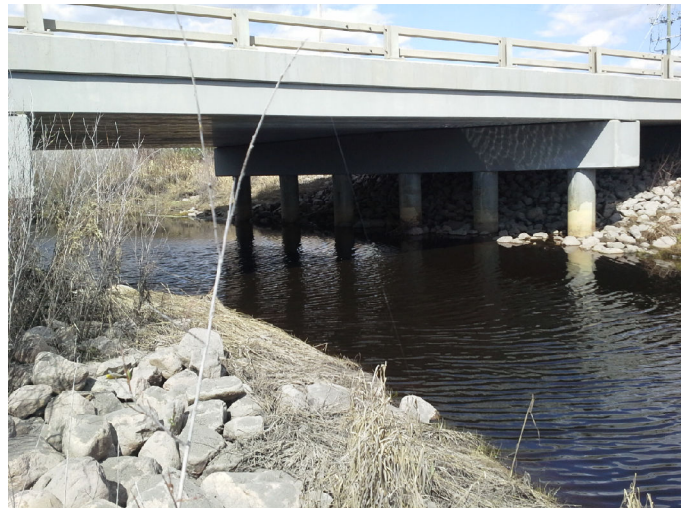
Photo No.: Photos-20180508-214009.jpg
Description: Outlet

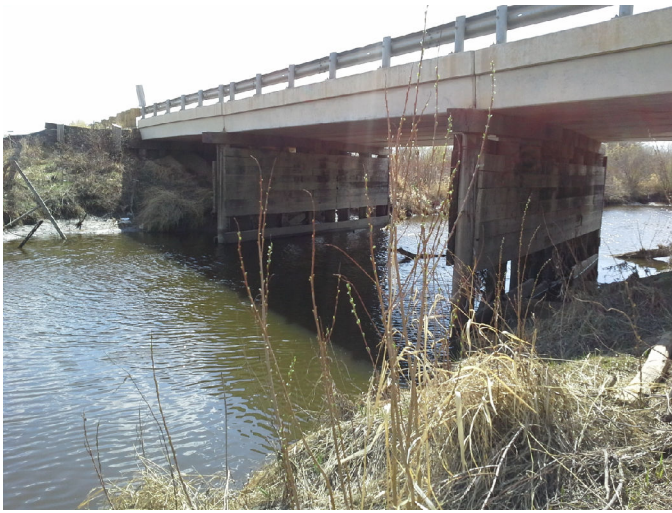
Photo No.: Photos-20180508-212420.jpg
Description: Outlet

Erosion at Site: Yes **Erosion Location (Inlet or Outlet):** Both

Erosion Source: Bank Slump

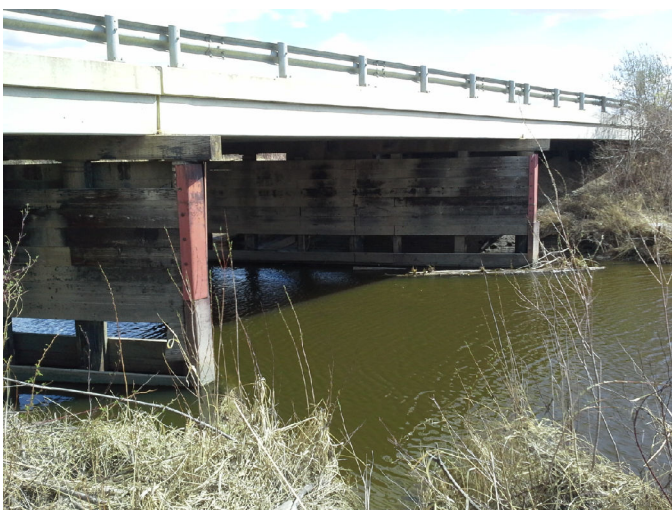
Photo No.: Photos-20180508-212638.jpg
Description: Inlet

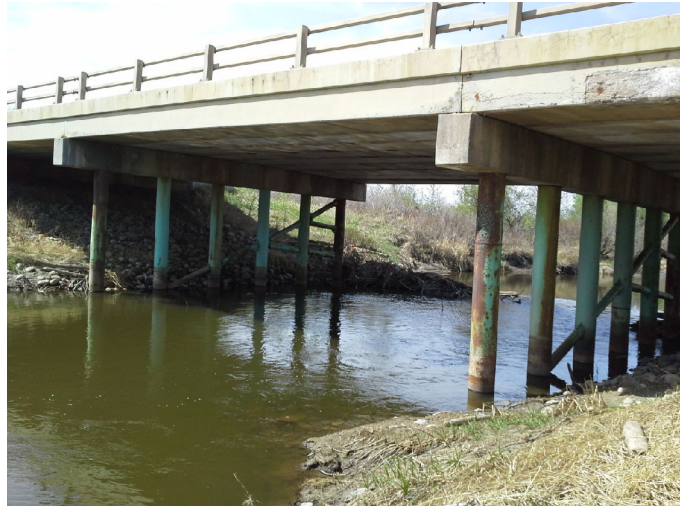
Photo No.: Photos-20180514-213953.jpg
Description: Outlet

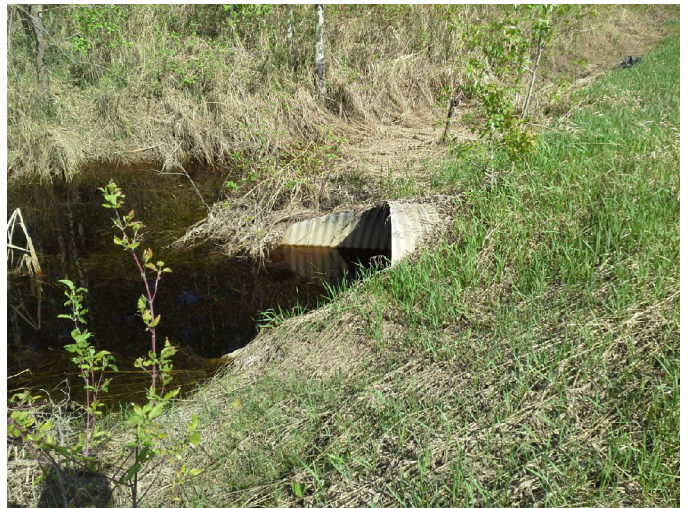
Photo No.: Photos-20180518-165807.jpg
Description: Culvert 1 - Outlet

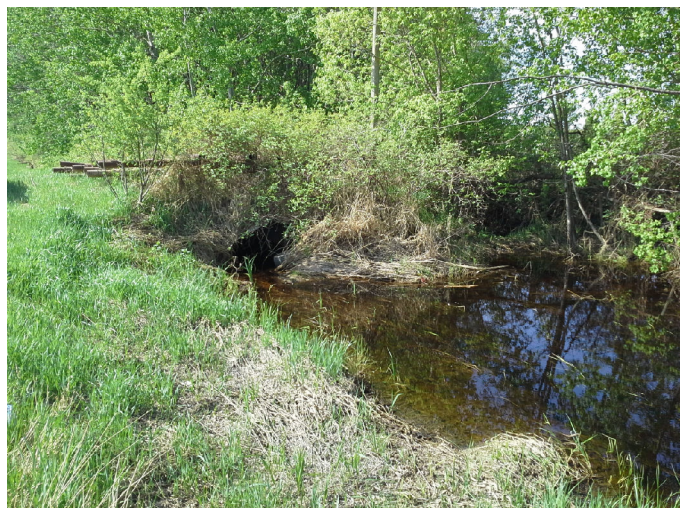
Photo No.: Photos-20180518-165939.jpg
Description: Culvert downstream from farm access road 20m downstream

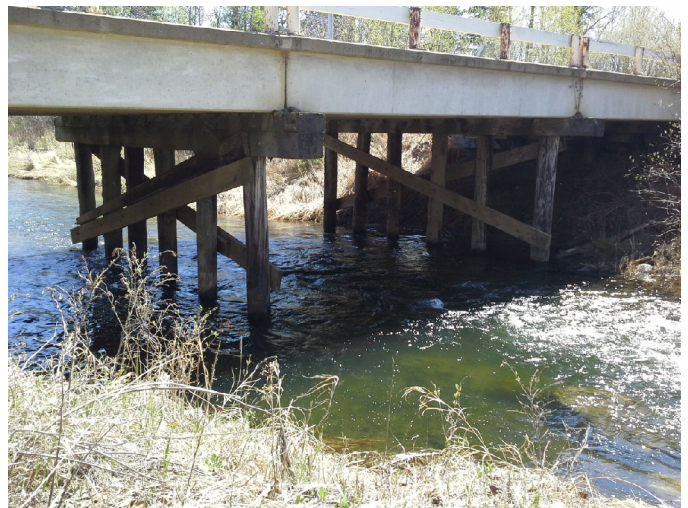
Comments: Fill slope erosion noted due to no armour present.

Photo No.: Photos-20180511-191311.jpg
Description: Inlet

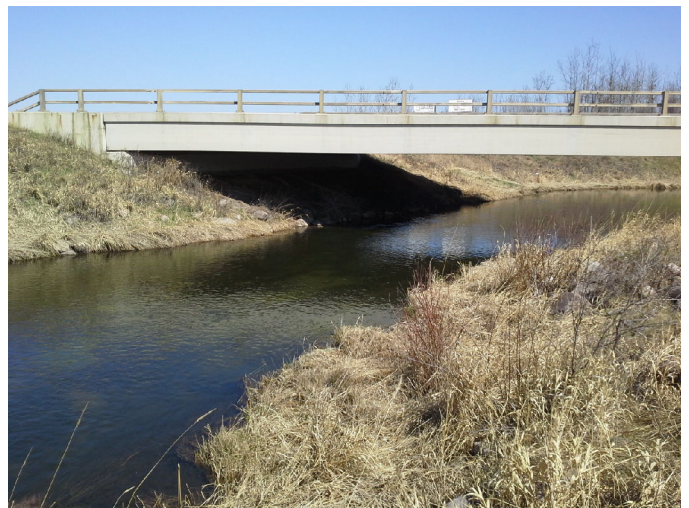
Photo No.: Photos-20180511-184145.jpg
Description: Downstream

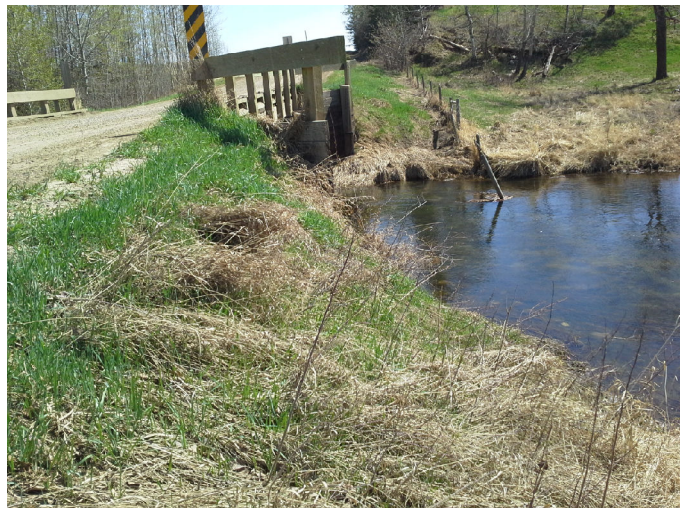
Photo No.: Photos-20180511-181239.jpg
Description: Possible erosion from road to bank

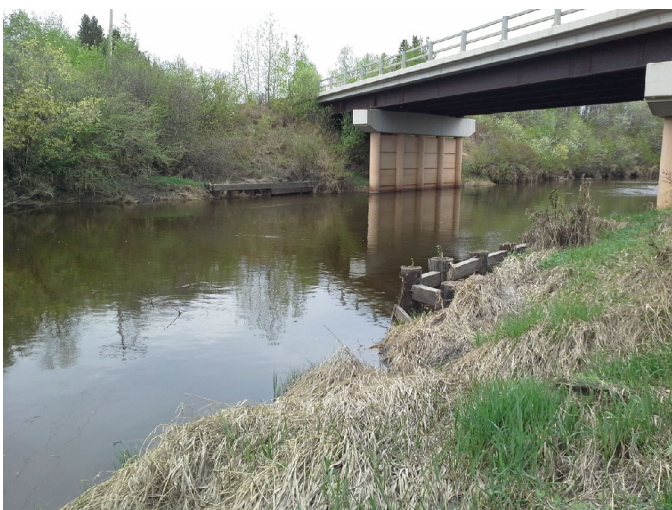
Photo No.: Photos-20180516-202538.jpg
Description: Erosion control?

Comments: Area below walking path is grass vegetated. This could lead to erosional issues.

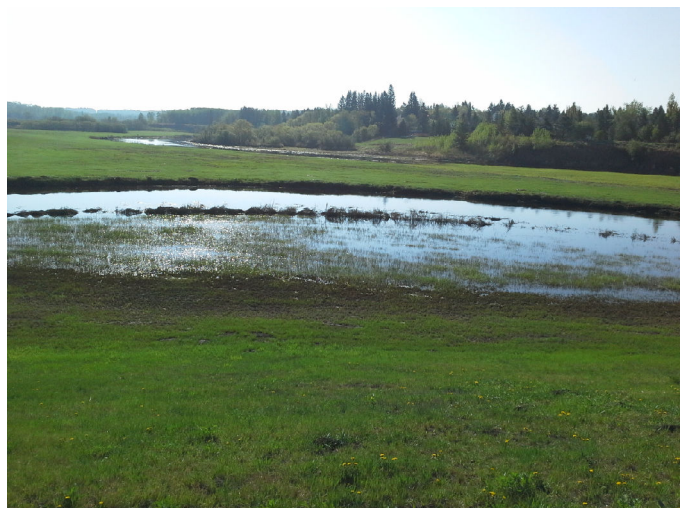
Photo No.: Photos-20180518-150002.jpg
Description: Areas upstream and downstream have small flood plains that are flooded

Comments: river and ice barges caused flooding across flood plain this past spring says landowner. old bridge abutments still in channel but lower than water level
