North Saskatchewan Watershed Alliance

Riparian Health Assessment of Wabamun Lake

An Aerial Assessment Using an Unmanned Air Vehicle

May 2015

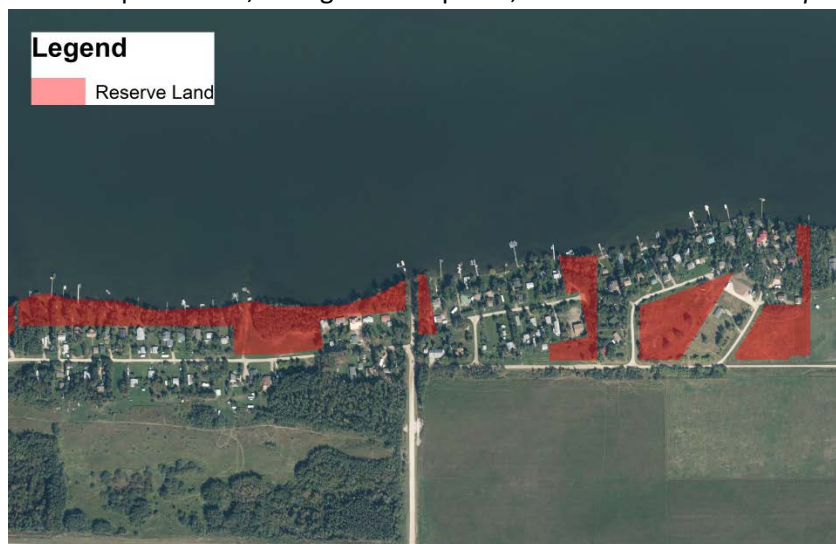
Figure 3 Example of Reserve Lands on Wabamun Lake. Reserve Lands are shown in red. All other lands in this image are held privately.

Lake shorelines in Alberta consist of both public and private lands. One modern ‘best management practice’ is to establish Reserve Lands (RL) between new developments and water bodies for the purpose of maintaining the natural condition of a shoreline. Reserve Lands are municipally owned spaces. Establishment of a Reserve Land is prescribed, though not required, under Alberta’s *Municipal Government Act*. When a municipality chooses to establish a Reserve Land, the *Municipal Government Act* prescribes that the municipality designate the Reserve Land using specific categories: environmental reserve, municipal reserve, school reserve, or road and utility reserve, etc. These categories are intended to establish a long-term purpose for each Reserve Land site.

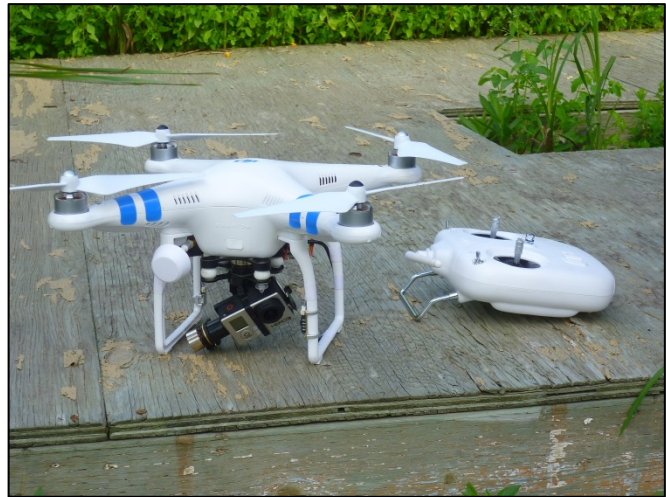
Figure 4 Photograph of the unmanned air vehicle (UAV), camera, and controller.

Video footage of Wabamun Lake was captured over three days in early August 2014. The unmanned air vehicle (UAV) (Figure 3) was launched from a boat that was provided by members of the Wabamun Watershed Management Council. A pontoon boat was used at first, but proved to be too slow to keep up with the UAV, so a speed boat was used instead. As the UAV captured data from the air, the 3-person crew followed below in the boat. The crew was made up of the boat pilot, the UAV pilot, and project manager who provided feedback on video footage while in the field. The UAV was navigated using a 5.8 GHz radio remote control, with the assistance of live footage that was broadcasted via Bluetooth from the UAV to a *SmallHD AC7* field monitor. Flight time was limited by the battery charge life (approximately 10-15 minutes); it was essential to have several batteries available to be recharged in the field.

Video footage was taken from a height of approximately 30-40 meters above lake level (ensuring that the entire RMA was visible) using a *DJI Phantom* Quadcopter UAV that housed a stabilized *GoPro Hero3* camera (weighing approximately 1.2 kg). The drone was flown at an approximate speed of 10 kilometers per hour. Footage was taken in full HD resolution (1920 x 1080 pixels) at 30 frames per second. Geo-spatial data were recorded using a *Flytrex Core 2.0* GPS data logger which was mounted to the drone.

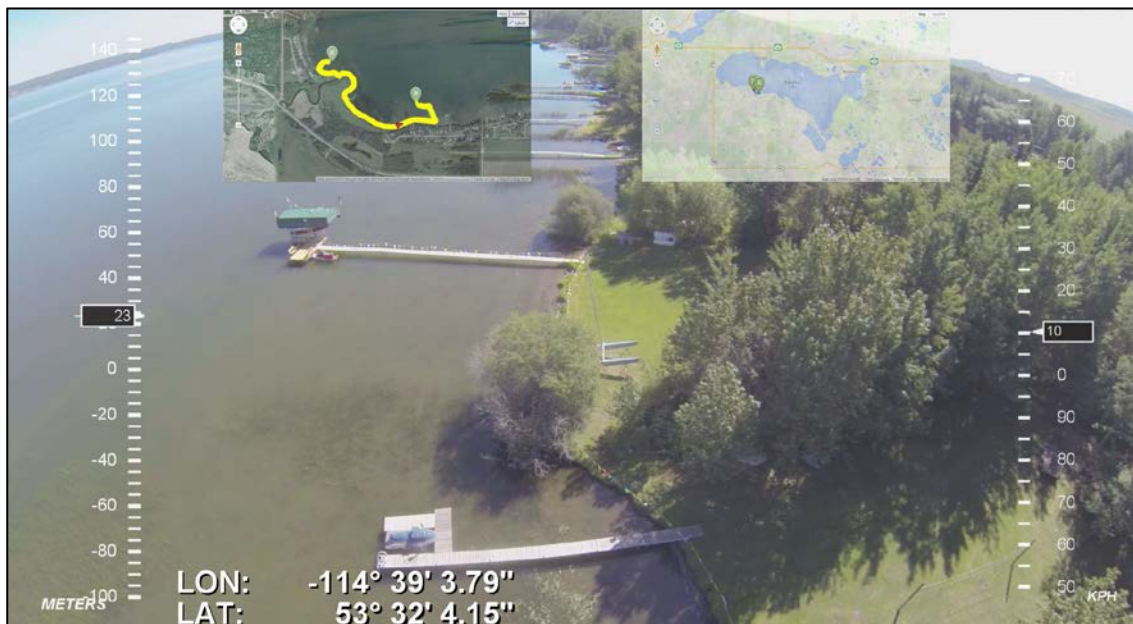
Figure 5 Screen shot of post-processed video footage. The footage now includes spatial data overlaid. The bar-scale on the left is measured in meters above the launch height. The bar-scale on the right is speed measured in kilometers per hour.

In the post-production processing step, *DashWare* software was used to synchronize the spatial data—including altitude, speed and GPS coordinates—with the video footage. A permanent video record now exists with the spatial data overlaid onto the video footage, making it possible to perform various assessments (Figure 4).

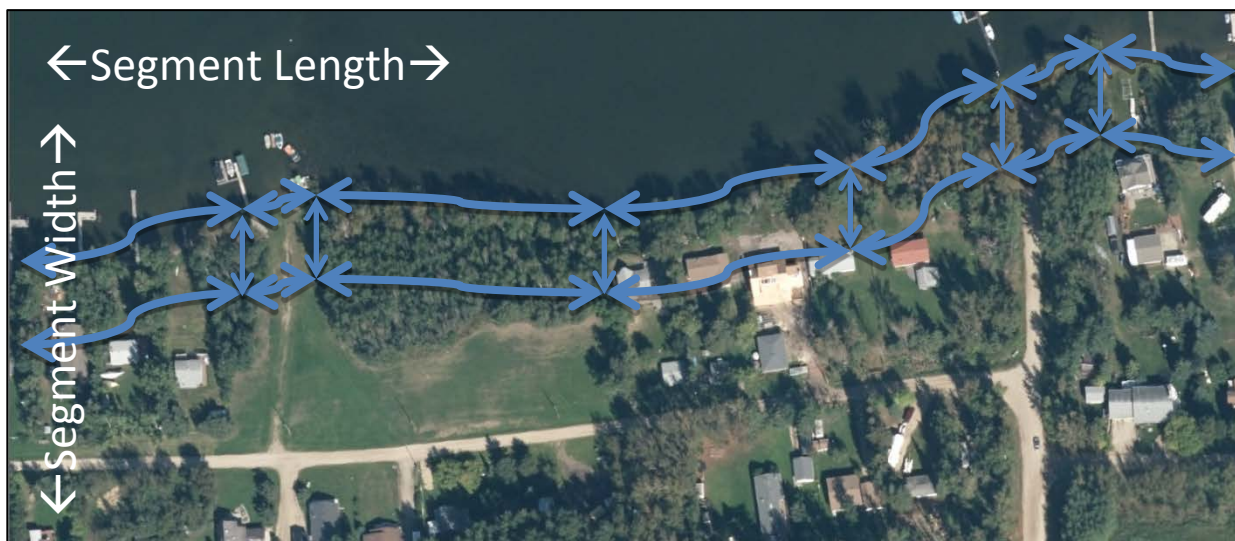
Figure 6 Diagram illustrating Riparian Management Area segments by length and width.

In the modification developed by Teichreb and Walker (2008) no attempt was made to assess the segment length by land ownership parcels; rather, the beginning and end of each segment is determined by homogeneity (sameness) of that segment. In other words, when there was a significant change in the condition of the RMA, a new segment would begin. The length of segments in this analysis can range from several meters to several kilometers, potentially spanning many ownership parcels and political boundaries (Figure 5).

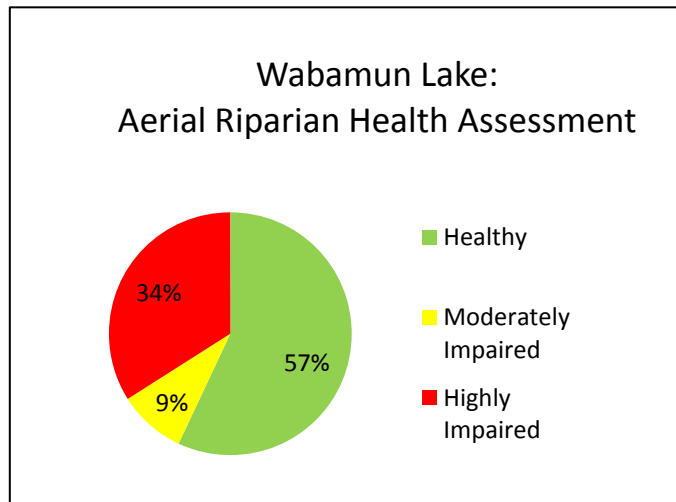
Figure 7 Results of the Wabamun Riparian Health Assessment.

To estimate an average health rating for Wabamun Lake, the sum of the weighted scores was calculated using segment length as the priority factor. The results of this study show that Wabamun Lake has a score of 7 out of 11 possible points, meaning that the Riparian Management Area (RMA) is moderately impaired in its capacity to perform riparian functions. This rating can be further broken down: 57% of the RMA is rated as healthy; 9% of the RMA is rated as moderately impaired; and 34% of the RMA is rated as highly impaired (Figure 6).

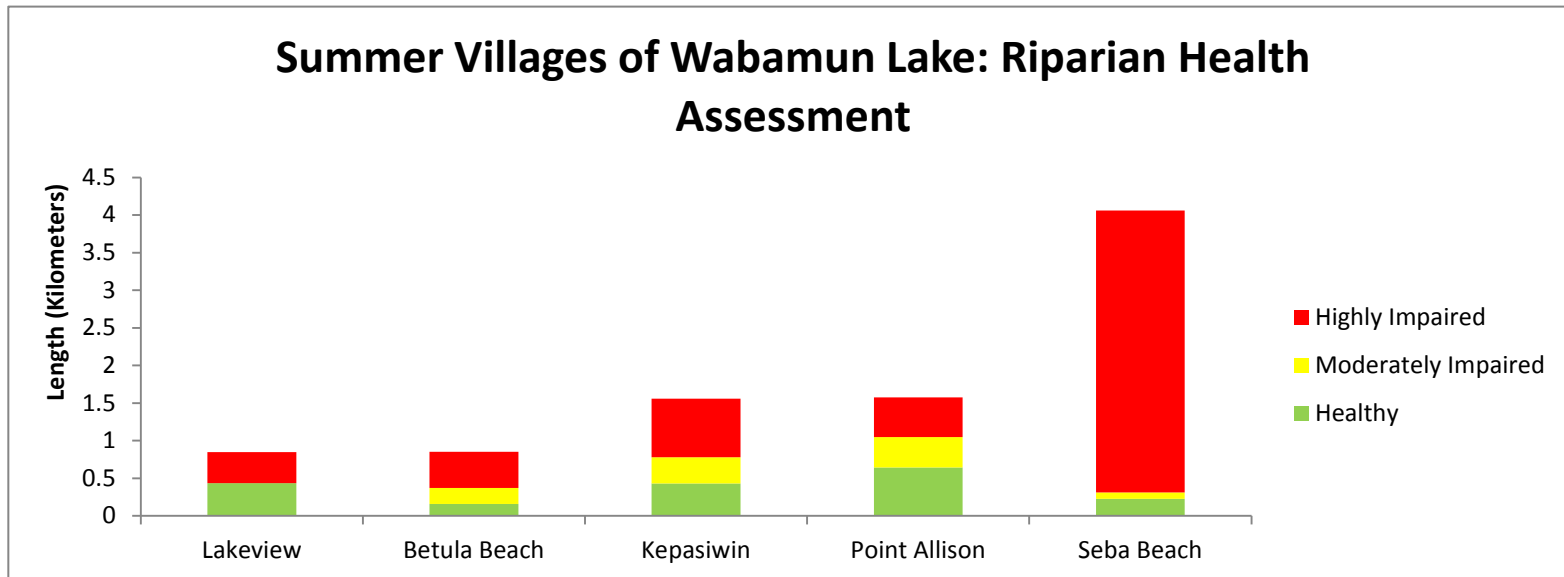
Figure 10 Summary of results comparing Summer Villages on Wabamun Lake.

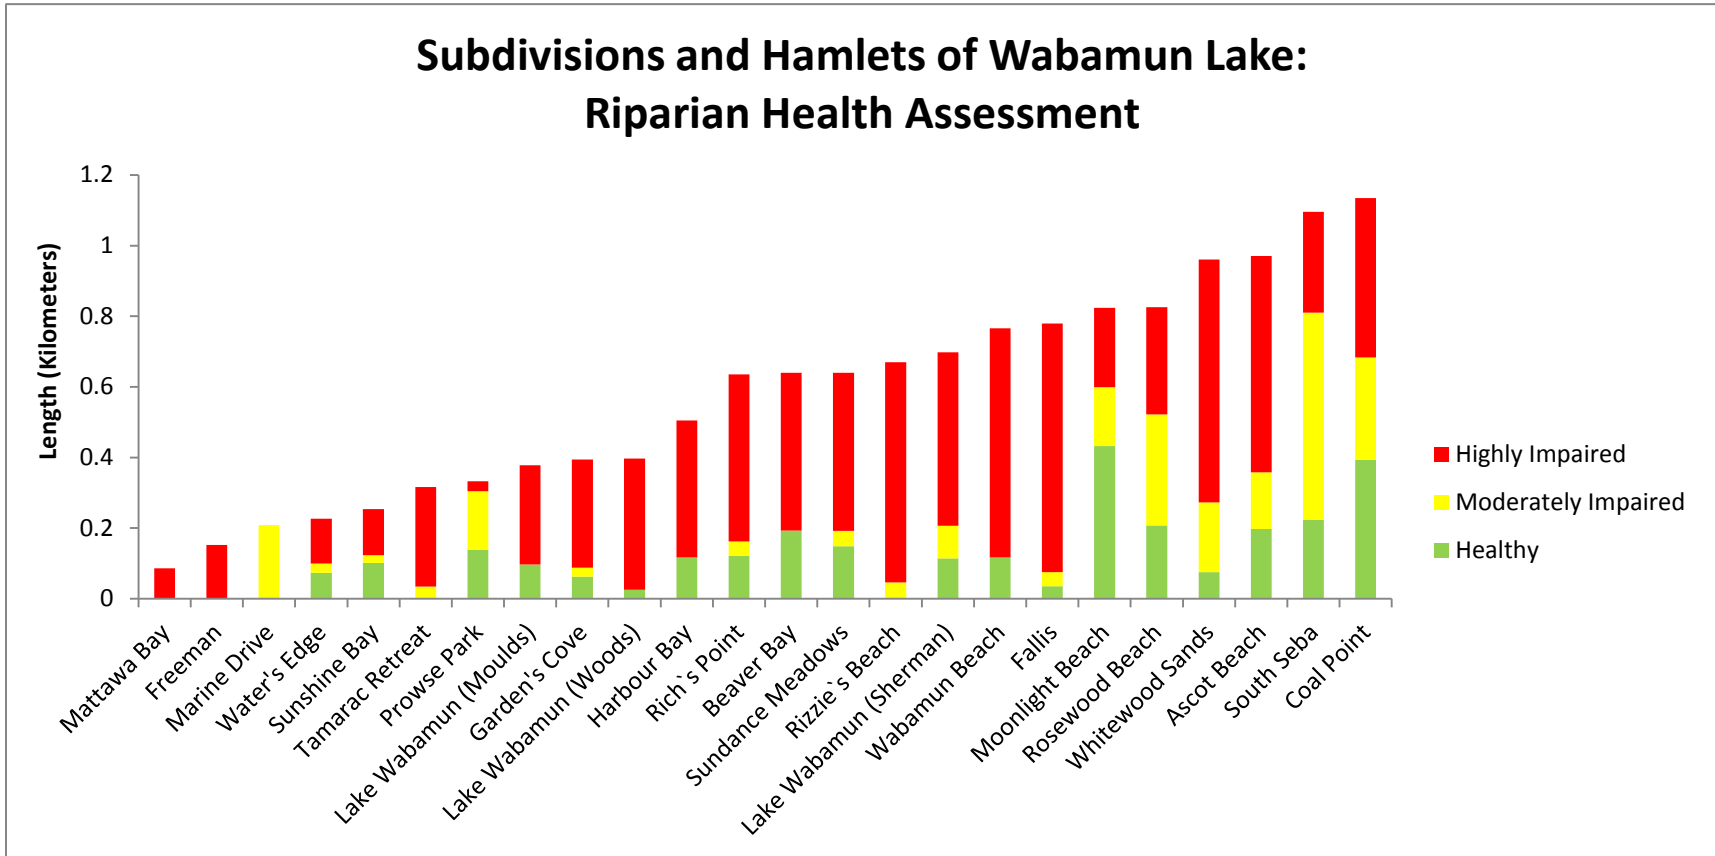
Figure 11 Summary of results comparing subdivisions and hamlets on Wabamun Lake.

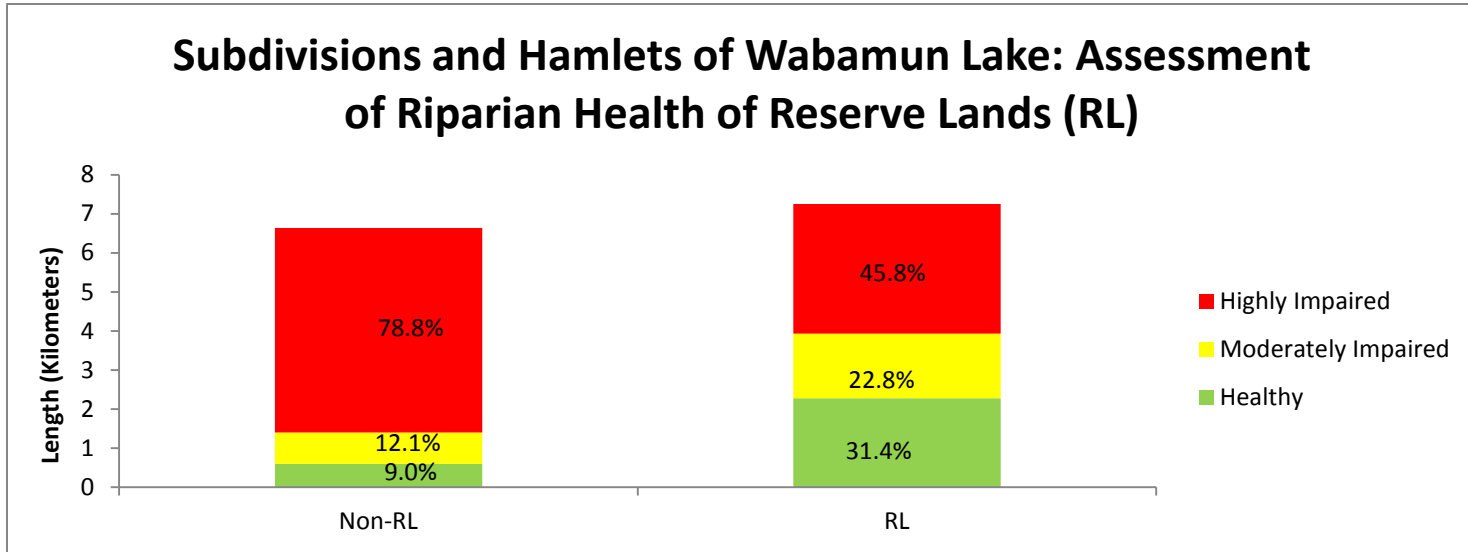
Figure 12 Summary of results comparing the health of Riparian Management Areas contained within Reserve Lands (RL) of subdivisions and hamlets. Results are compared to non-Reserve Lands (non-RL) of subdivisions and hamlets. Reserve Lands refer to land located adjacent to Wabamun Lake that is owned by the municipality.

Approximately 52% of the RMA within Parkland County's subdivisions and hamlets is contained within Reserve Lands (Figure 11). This assessment of this RMA indicates that 31% is healthy, 23% is moderately impaired and 46% is highly impaired. It was evident that adjacent landowners were often using these Reserve Lands as a continuation of their own private properties. Despite this, RMAs contained within Reserve Lands have markedly better scores compared to RMAs contained within private properties, wherein only 9% are healthy, 12% are moderately impaired and 79% are highly impaired.

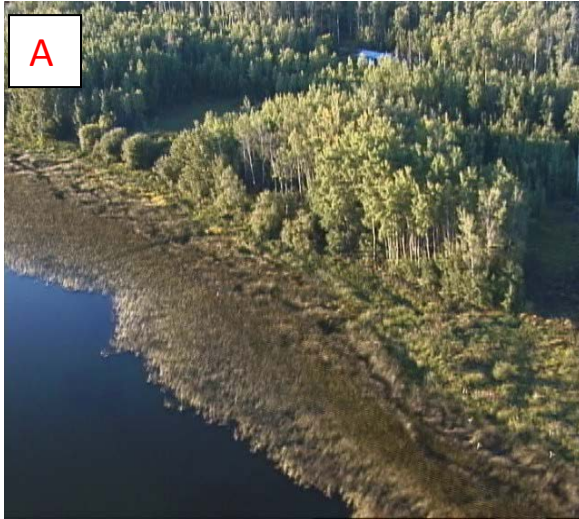
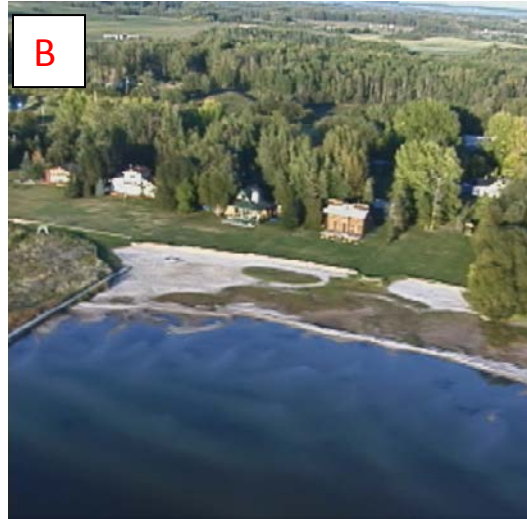
7. What picture does most of the polygon look like?

Picture A? ___ (1 point) Combination of A and B? ___ (0.5 points) Picture B? ___ (0 points)
