## 3.0 Watershed Characteristics

## **Antler Lake State of the Watershed Report**

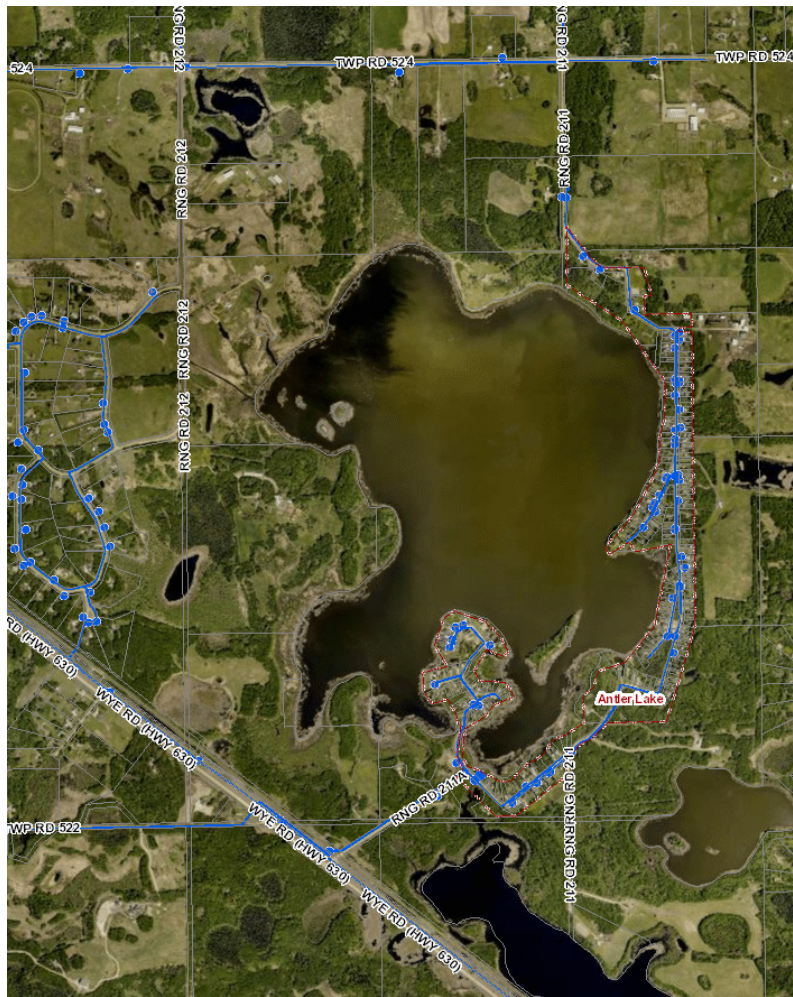
Figure 36. EPCOR Potable Water Service System Map (Strathcona County, n.d.). The blue line represents the potable water service line from the City of Edmonton to Beaver County.

Strathcona County Utilities operates and maintains all utilities, including drinking water and wastewater services for the Hamlet of Antler Lake. Strathcona County’s drinking water comes from the North Saskatchewan River, which originates at the Saskatchewan Glacier in the Rocky Mountains, 500 km southwest of Edmonton. Strathcona County receives its water from EPCOR Water, which operates two water treatment plants in Edmonton, producing a total capacity of 530 million liters of water per day (Figure 35).
