# TECHNICAL MEMORANDUM

BLACKMUD/WHITEMUD CREEK  
WATERSHED MANAGEMENT STUDY

## Appendix C – Erosion Site Photos

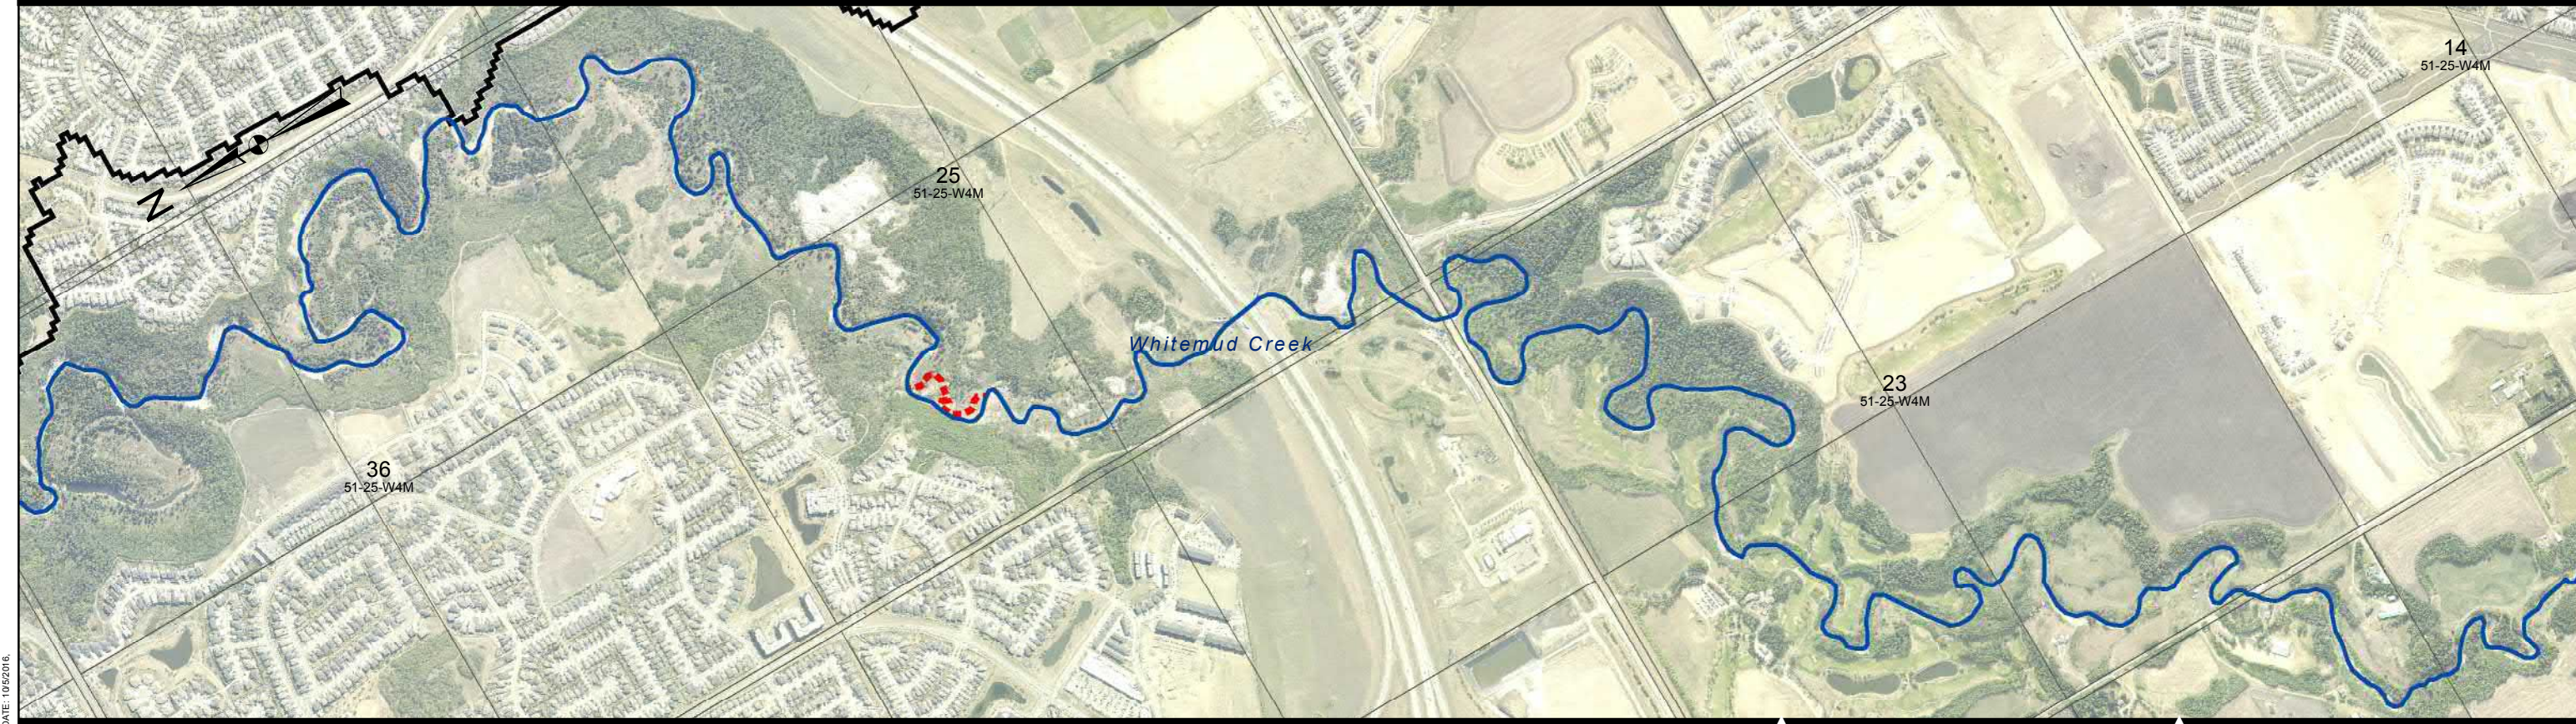
**FIGURE No. A-1**  
 BLACKMUD/WHITEMUD CREEK  
 WATERSHED MANAGEMENT STUDY  
 ENVIRONMENTAL  
 HISTORIC CREEK CHANNEL  
 WHITEMUD CREEK

**Legend:**  
— Whitemud Creek (2012)  
- - - Whitemud Creek (1949)

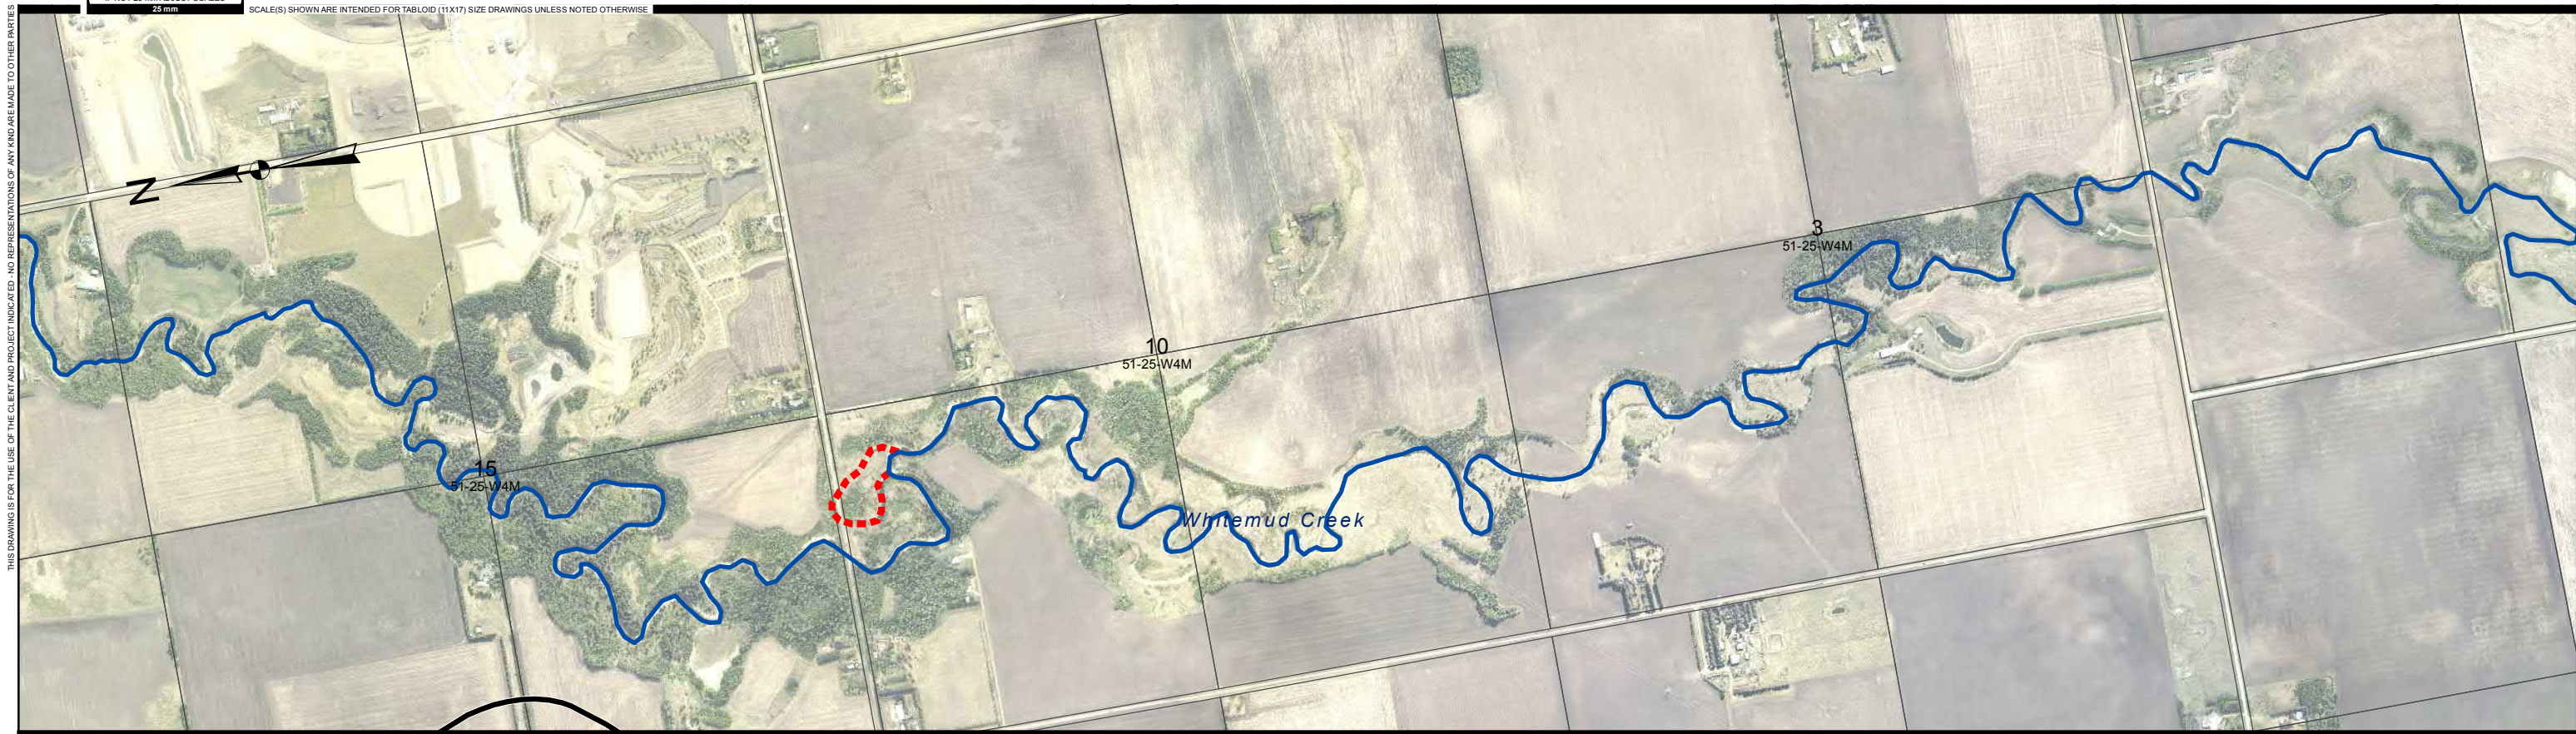
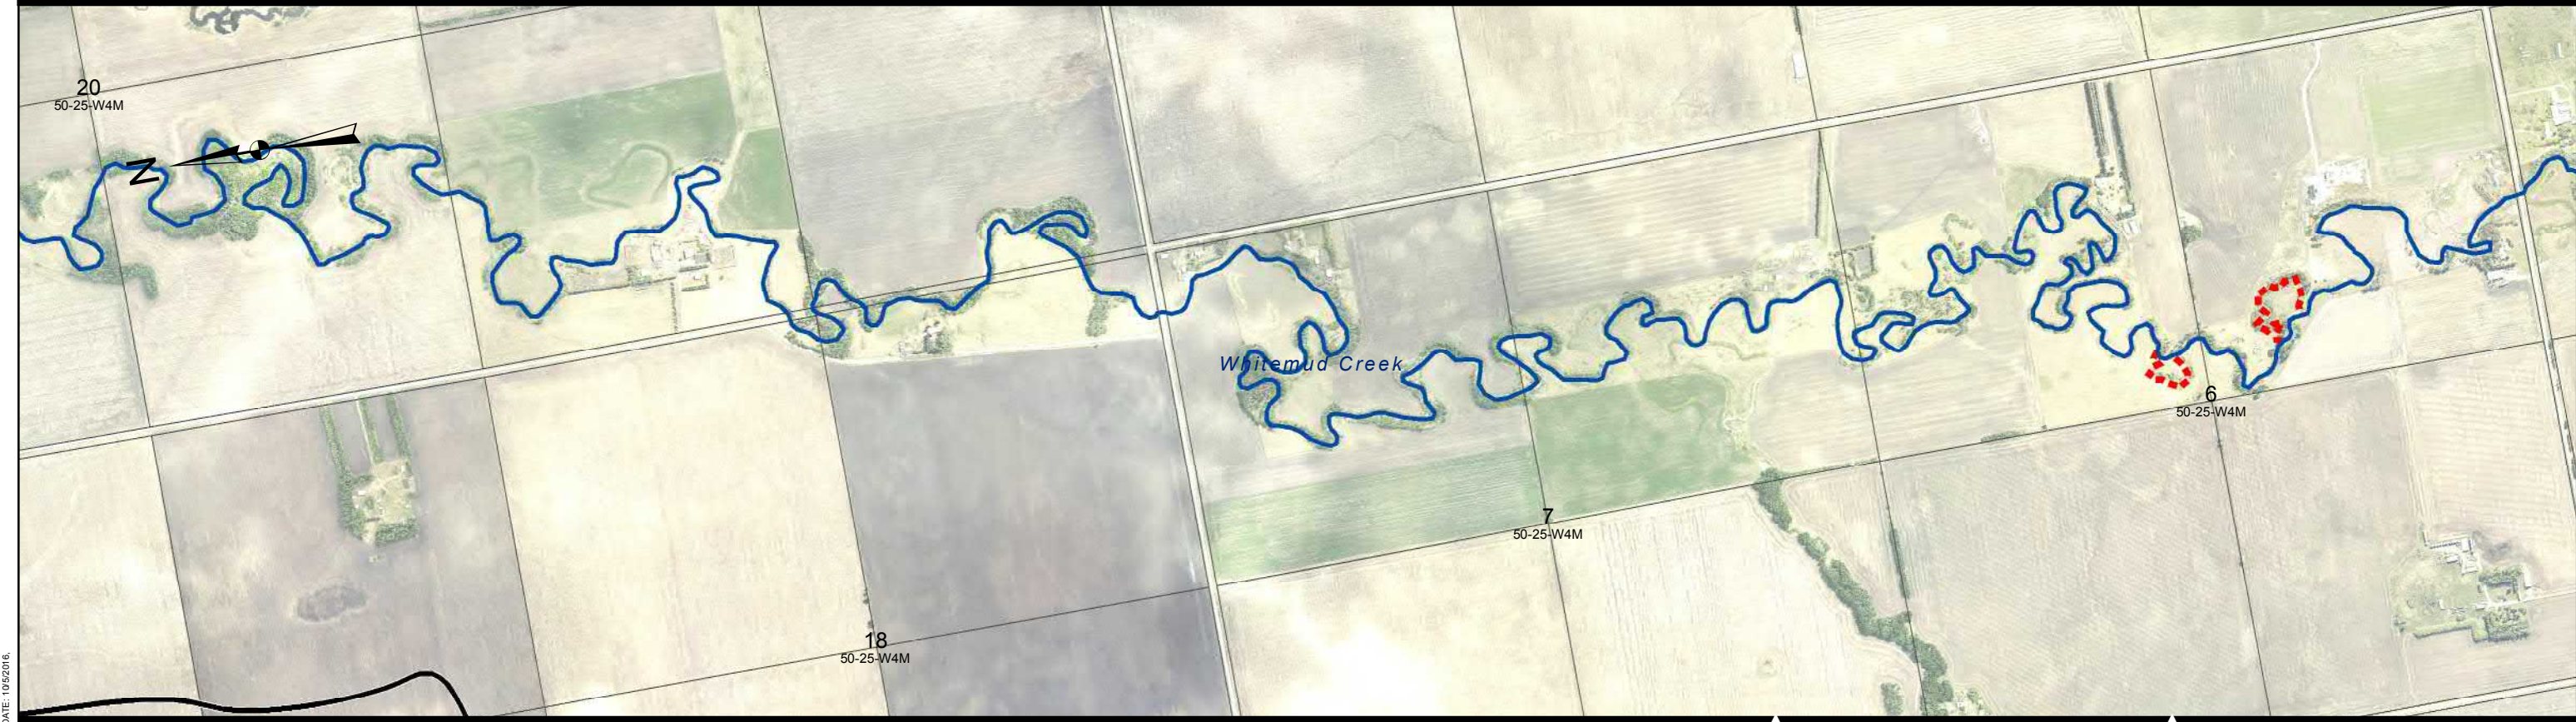
**FIGURE No. A-2**  
 BLACKMUD/WHITEMUD CREEK  
 WATERSHED MANAGEMENT STUDY  
 ENVIRONMENTAL  
 HISTORIC CREEK CHANNEL  
 WHITEMUD CREEK

**Legend:**  
 ——— Whitemud Creek (2012)  
 - - - - - Whitemud Creek (1949)

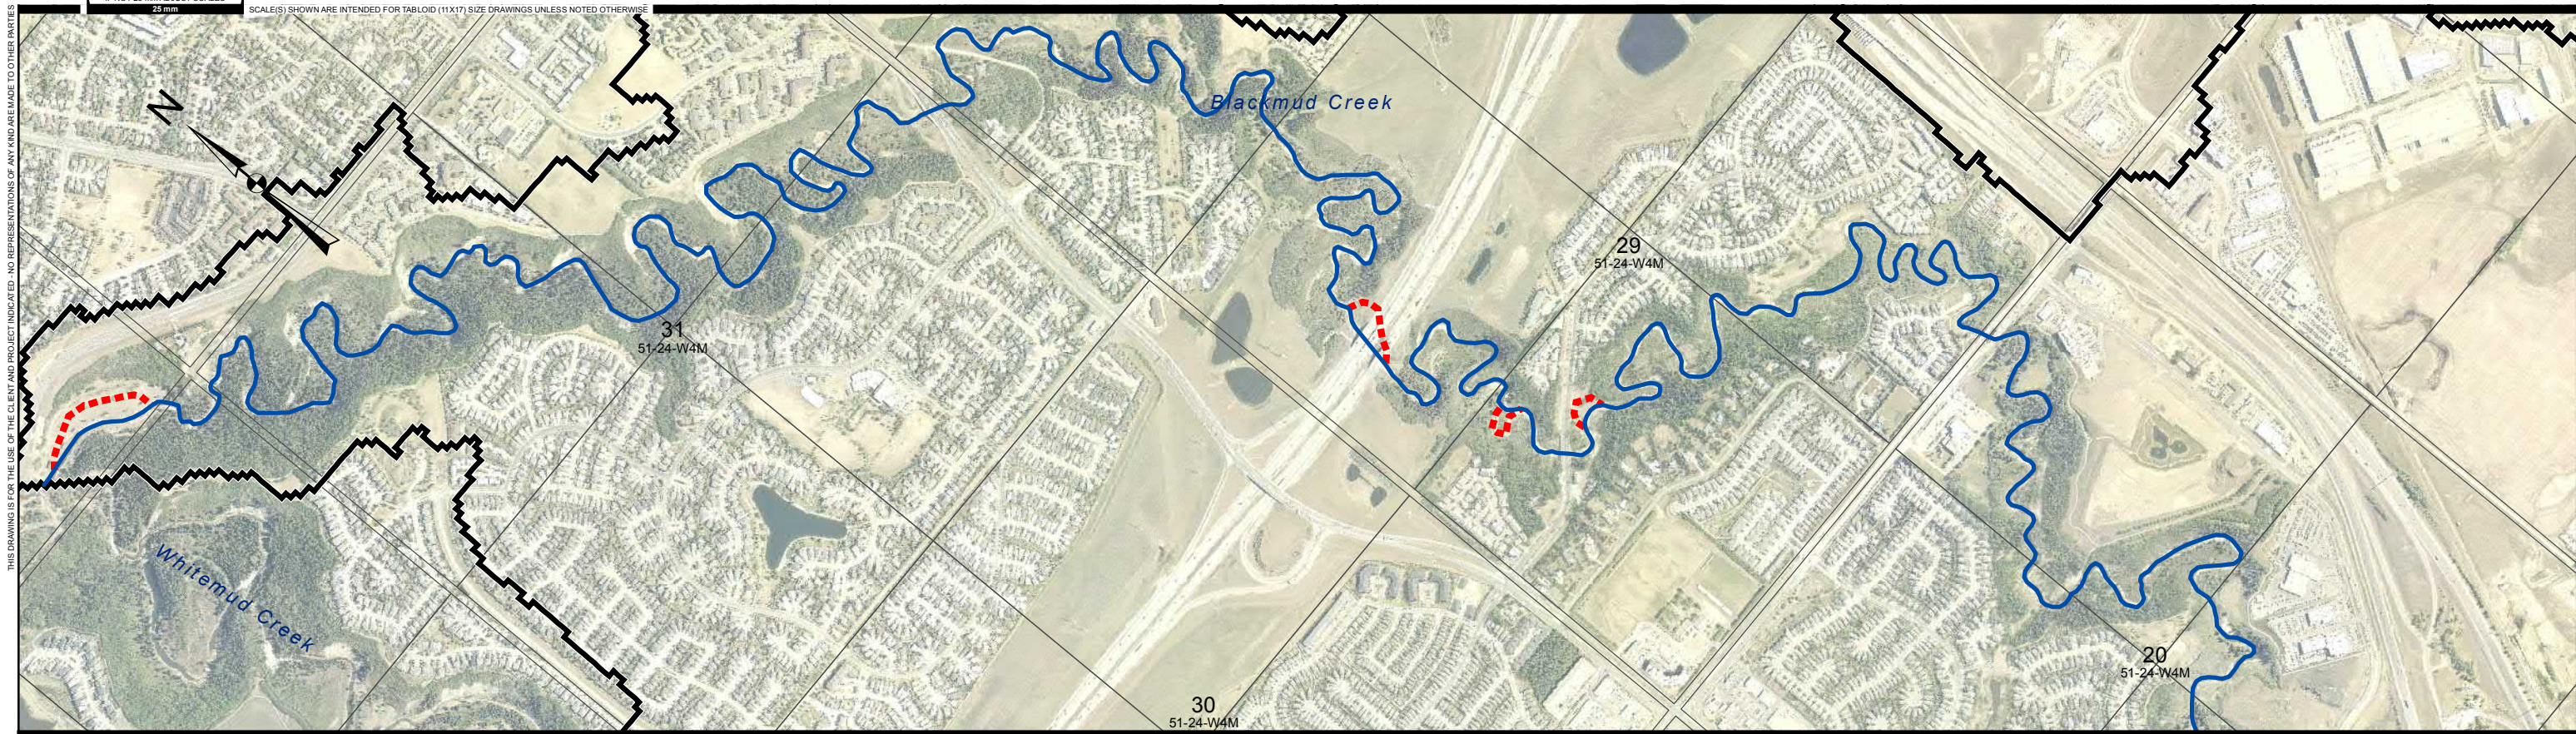
**FIGURE No. A-3**  
 BLACKMUD/WHITEMUD CREEK  
 WATERSHED MANAGEMENT STUDY  
 ENVIRONMENTAL  
 HISTORIC CREEK CHANNEL  
 BLACKMUD CREEK

**Legend:**  
— Blackmud Creek (2012)  
- - - Blackmud Creek (1949)

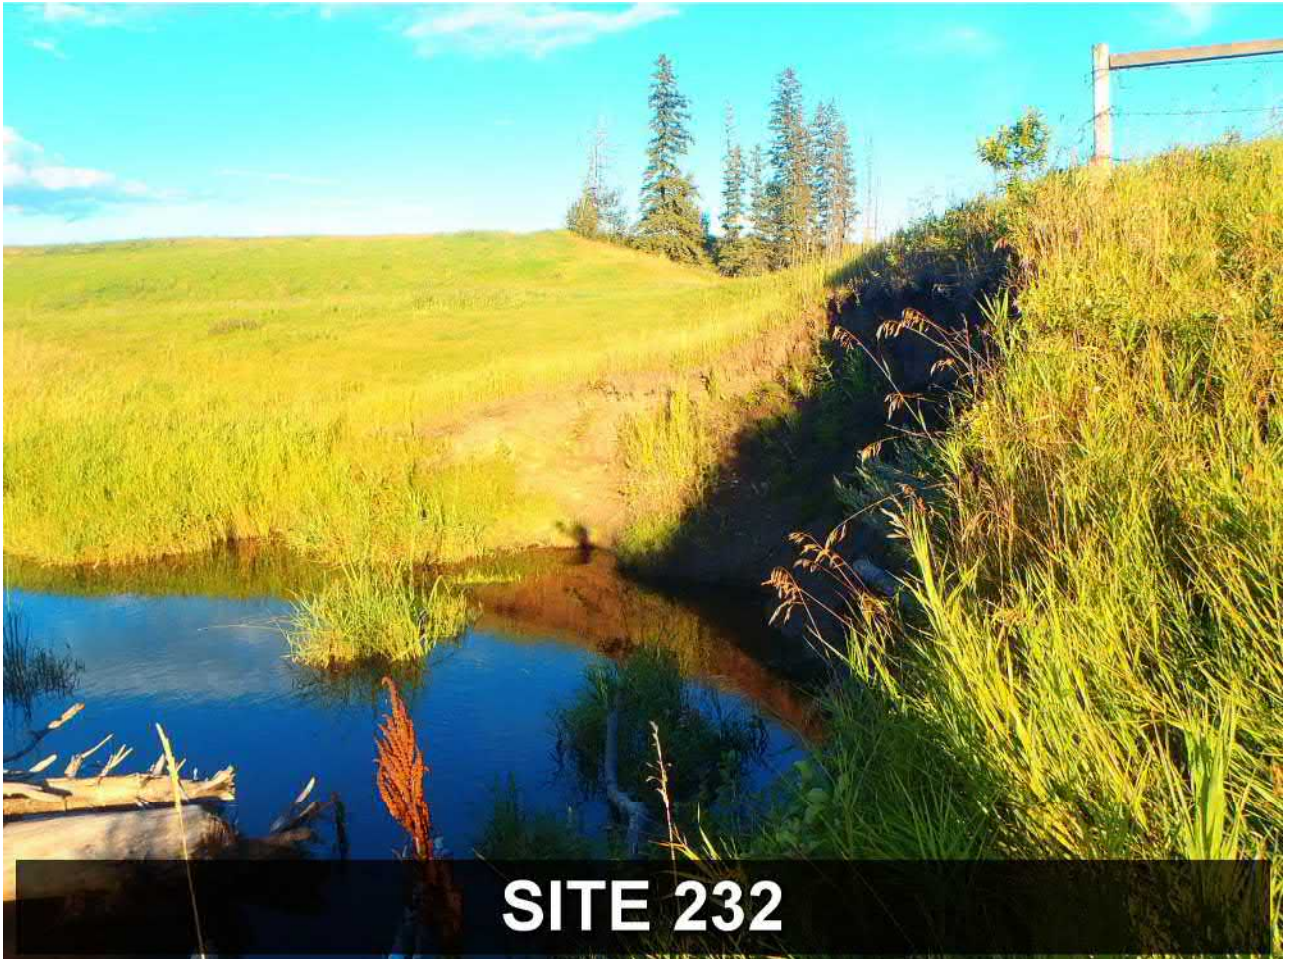
**SITE 232**

232	Blackmud Creek	Lower	-113.512584	53.403991	I	Right	3	40-90	15	N/S	buckbrush, grasses, creeping thistle	90	20	20	0	50	2	Fence impeding flow, undercut banks, slumping	No	No
233	Blackmud Creek	Lower	-113.51161	53.403113	I	Left	3	40-90	15	E	buckbrush, grasses, creeping thistle	90	20	20	0	50	0	Undercut banks, slumping	No	No
234	Blackmud Creek	Lower	-113.5126	53.40266	I	Left	3	40-90	15	E	buckbrush, grasses, creeping thistle	90	20	20	0	50	2	Fence impeding flow, undercut banks, slumping	Potential to Flood Farmland	No
235	Blackmud Creek	Lower	-113.513676	53.399852	I	Right	3	25	100	N	balsam poplar, buckbrush, osier red dogwood, grasses, meadow thistle	95	10	25	0	95	25	Undercut banks, slumping, erosion at toe	Stormwater Pond 40 m away	No
236	Blackmud Creek	Lower	-113.51555	53.401215	I	Left	8	40	5	E	prickly rose, buckbrush, grasses	95	0	40	0	60	20	Slumping, erosion at toe	Road 25 m away	No
237	Blackmud Creek	Lower	-113.515898	53.398643	I	Left	2	30	20	SE	balsam poplar, blue spruce, buckbrush, prickly rose, osier red dogwood, grasses, creeping thistle	99	3	17	2	80	20	Slumping	House 30 m away, trail 20 m away	No

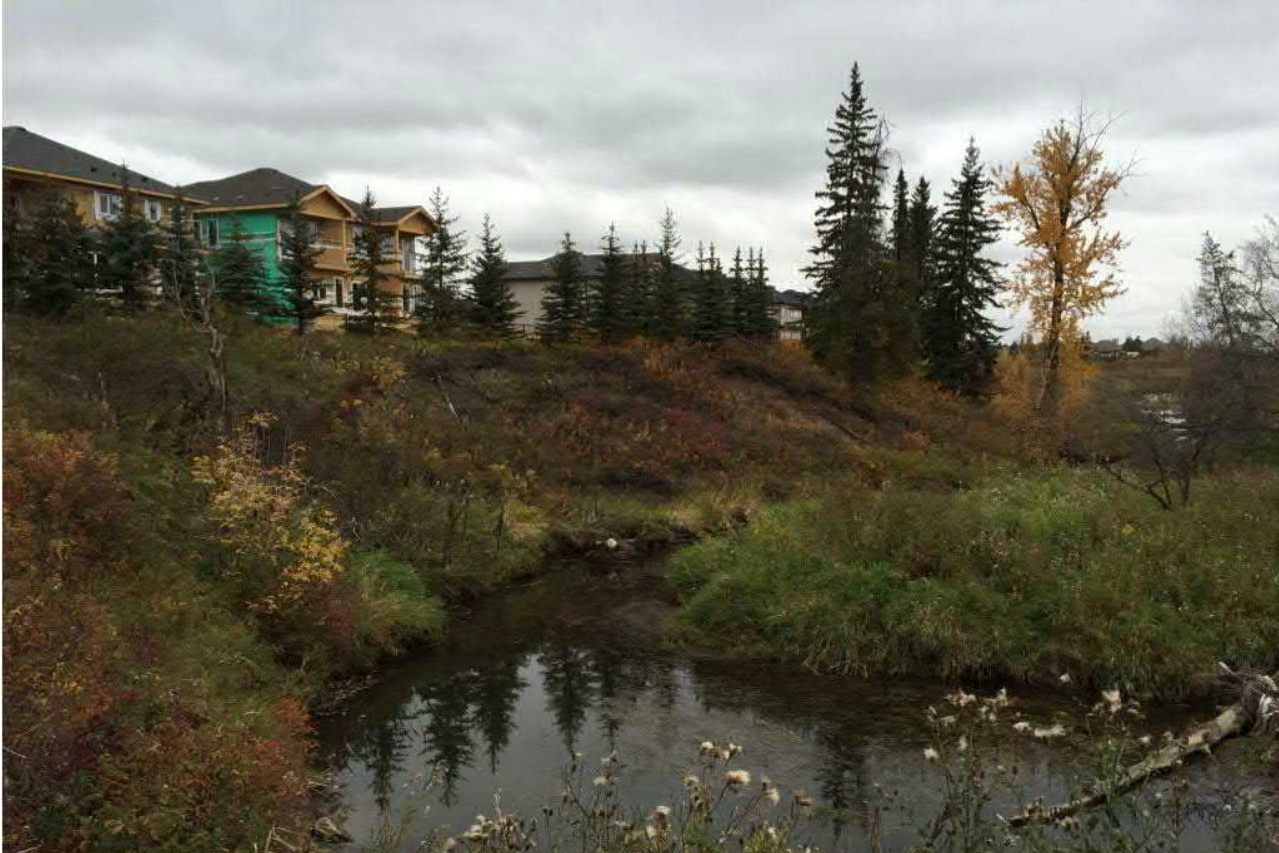
**SITE 238**

238	Blackmud Creek	Lower	-113.517656	53.397051	I	Left	5	45	30	E	balsam poplar, trembling aspen, white spruce, wild red raspberry, osier red dogwood, Saskatoon,	95	1	52	1	90	45	Slumping	Trail 14 m away	No

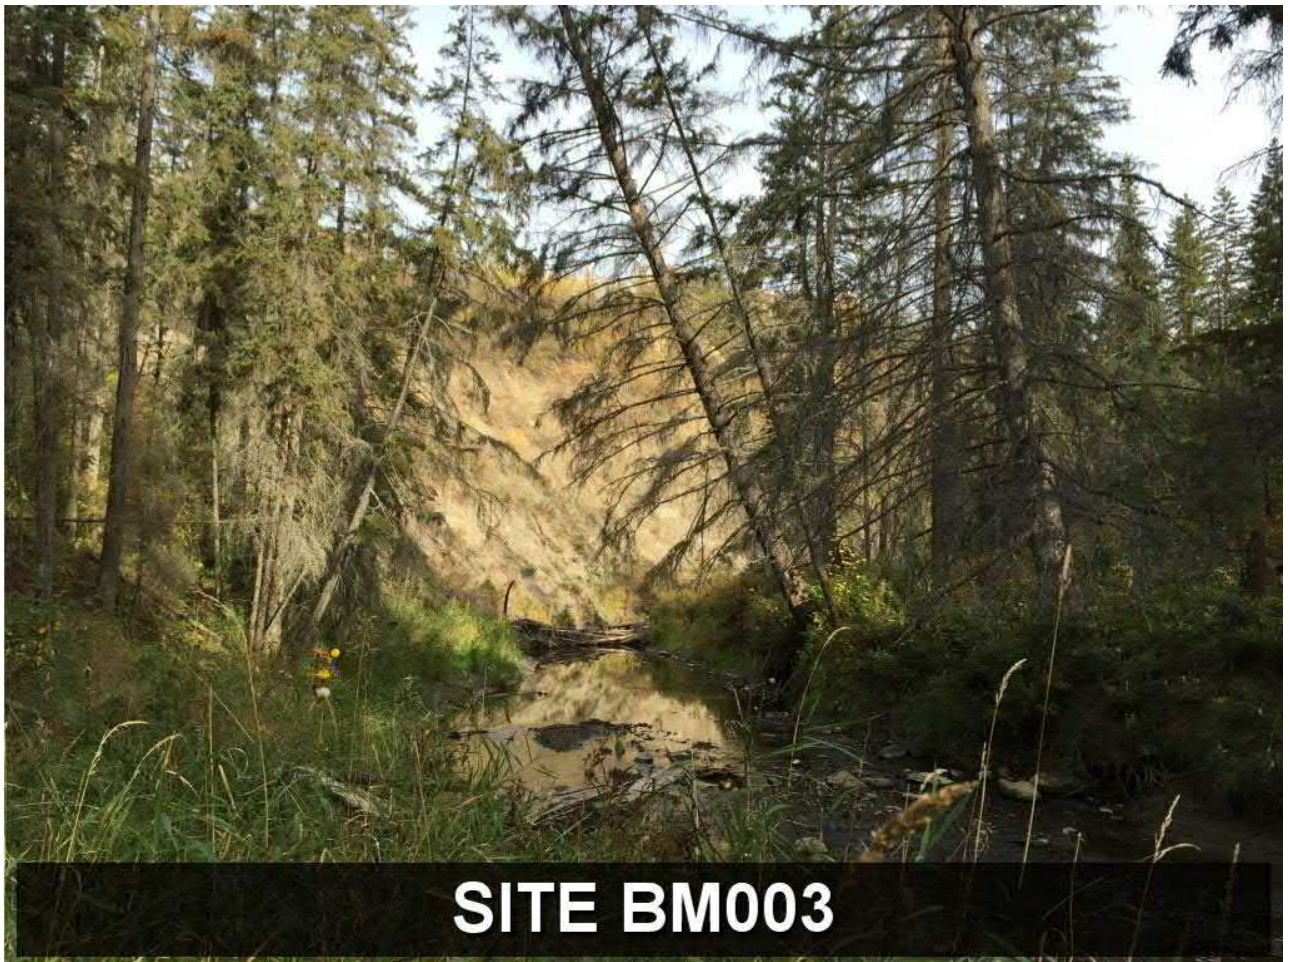
**SITE BM003**

BM0 03	Blackmud Creek	Lower	-113.5336874	53.4516481	ID	Right	25	70	75	SE	white spruce, trembling aspen, balsam poplar, willow spp., buckbrush, pin cherry, wolf willow, Saskatoon, grasses	85	0	72	15	50	10	* dft pile impeding flow, slumping, erosion at toe, bedrock exposure, uprooted vegetation	Parking lot 10 m away, condos 30 m away	Yes - mass wasting, steep slope, access from road
BM0 04	Blackmud Creek	Lower	-113.5309257	53.45100575	SD	Right	25	65-90	50	SW	trembling aspen, prickly rose, buckbrush, pin cherry, grasses	50	0	50	5	0	2	Slumping, erosion at toe, bedrock exposure	Condos 65 m away, Road 40 m away	Yes - mass wasting, steep slope, access from road
BM0 05	Blackmud Creek	Lower	-113.5292689	53.44931049	SD	Right	30	50-90	75	S	trembling aspen, buckbrush, pin cherry, grasses	60	0	50	10	0	2	Slumping, erosion at toe, bedrock exposure	Trails/park upslope	Yes - mass wasting, steep slope, access from road/trail

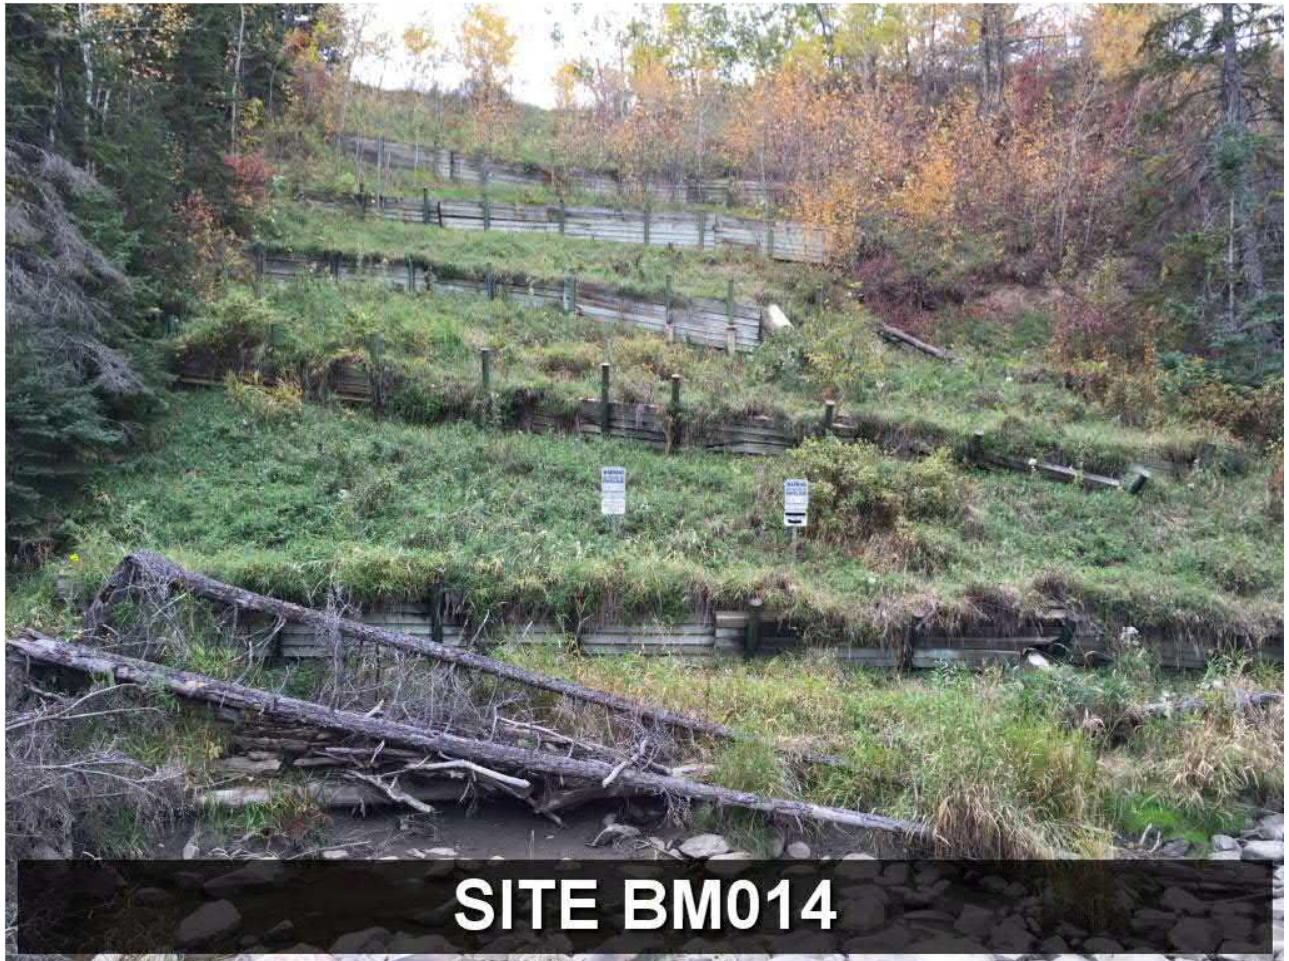
**SITE BM014**

BM0 14	Blackmud Creek	Lower	-113.51073979400	53.44117156700	SD	Left	15	45	75	E	balsam poplar, buckbrush, prickly rose, trembling aspen, grasses, perennial sow thistle	100	1	10	0	100	100	* Recent & Past Slumping	Park, private yards and trail within 25 m	No
BM0 23 / 211	Blackmud Creek	Lower	-113.50365710200	53.41675993300	I	Left	8			S	willow spp., prickly rose, buckbrush, grasses, sedges	90	0	15	10	65	1	Slumping	No	No

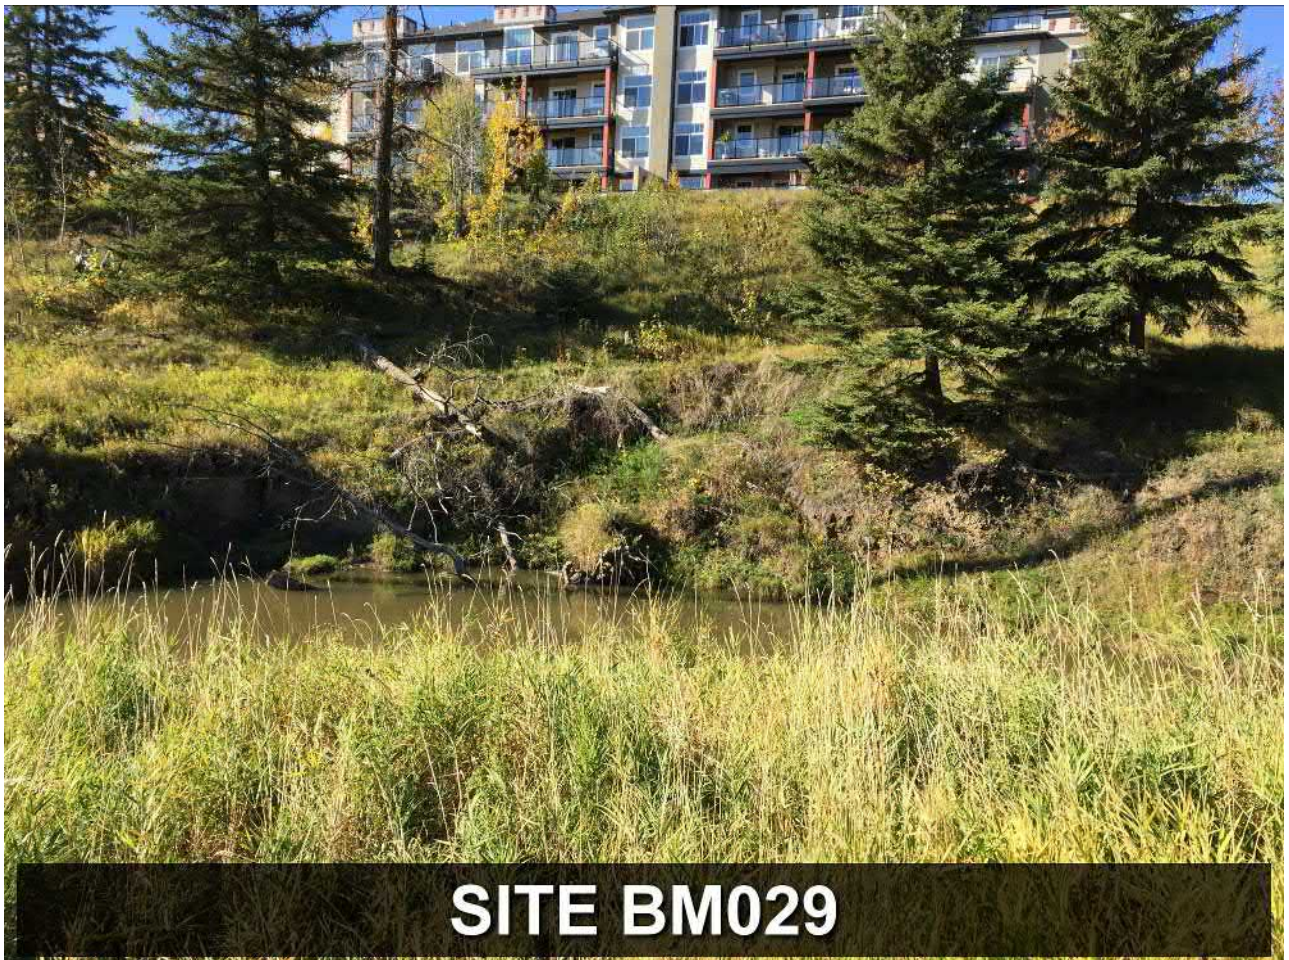
**SITE BM029**

BM0 28 / 217	Blackmud Creek	Lower	- 113.51674153 400	53.414463064 00	I	Right	2	70-80	10	N	white spruce, grasses	10	0	1	0	0	20	Slumping	Road 15 m away	No
BM0 29	Blackmud Creek	Lower	- 113.51874196 000	53.414776954 00	ID	Left	6	45	30	E	white spruce, trembling aspen, balsam poplar, prickly rose, grasses, perennial sow thistle	80	1	33	5	50	2	Slumping	Trail 16 m away	No
BM0 30 / 221	Blackmud Creek	Lower	- 113.51793073 800	53.414139405 00	ID	Right	5	60-90	100	SW	white spruce, prickly rose, grasses, creeping thistle	70	5	10	0	0	5	Undercut Banks, Slumping, Erosion at Toe	No	No
WM 006	Whitemud Creek	Lower	- 113.55533629 100	53.486138871 00	SD	Right	15	70	40	S/SW	grasses, prairie sedge, creeping thistle	45	1	0	0	0	0	Undercut banks, slumping, erosion at toe	No	No - slope could be concern
WM 007	Whitemud Creek	Lower	- 113.55262434 300	53.485472563 00	I	Right	6	70	15 + 20	W	balsam poplar, white spruce, white birch, pin cherry, red osier dogwood, prickly rose, aster spp., grasses, common tansy, perennial sow thistle, creeping thistle	50	6	16	20	0	5	Erosion at toe, bedrock exposure, uprooted vegetation	Outfall	No

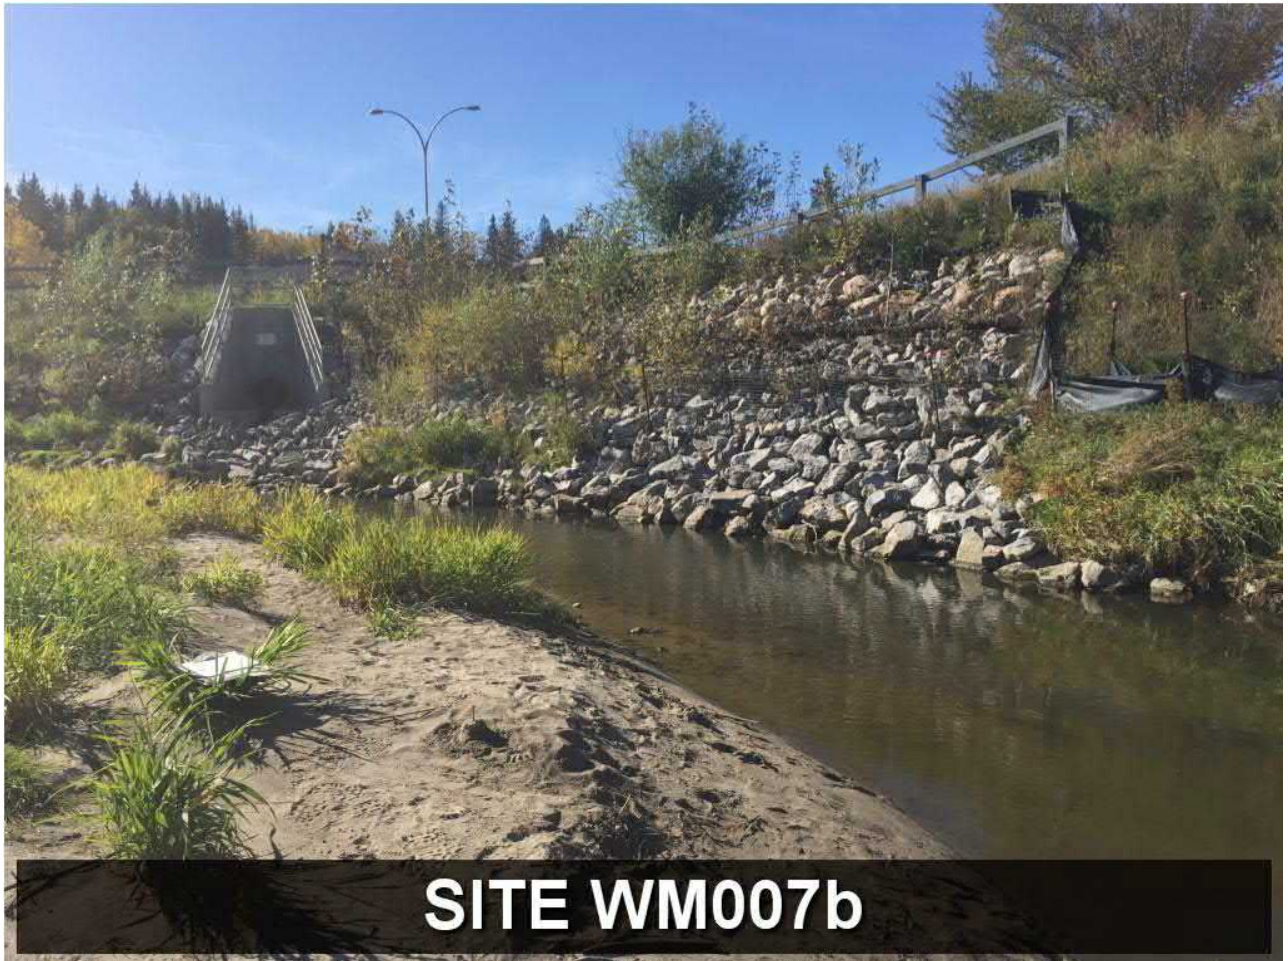
**SITE WM007b**

WM 007b	Whitemud Creek	Lower	- 113.55459090 000	53.484077100 00	I	Left	4	90	10	SE	trembling aspen, white spruce, willow spp., prickly rose, buckbrush, Saskatoon, red osier dogwood, pincherry, grasses, asters, common tansy, perreniel sow thistle, creeping thistle	85	4	85	1	50	95	Slumping, uprooted vegetation	Campground, Road, Outfall	No
WM 009	Whitemud Creek	Lower	- 113.55346864 000	53.476821773 00	SD	Right	40	45	140	S/SW	trembling aspen, buckbrush, prickly rose, grasses, prairie sage, perennial sow thistle	20	2	8	10	0	5	Slumping, Erosion at toe	Upslope House	No - slope could be concern
WM 009b	Whitemud Creek	Lower	-113.555417	53.473466	ID	Right	15	70	45	W/NW	white spruce, lodgepole pine, trembling aspen, prickly rose, red osier dogwood, alder, Saskatoon, grasses	20	0	17	2	0	2	Slumping	Trails 35 m away	Yes - Steep banks and forested, but trail present
WM 010 (W M00 9b on field	Whitemud Creek	Lower	- 113.56381509 500	53.472690074 00	ID	Left	40	70-90	160	E/SE	trembling aspen, white spruce, prickly rose, buckbrush, wolf willow, grasses	20	0	18	1	100	0	Slumping, erosion at toe, bedrock exposure, uprooted vegetation	House 30 m away	No - access through private backyards and trail
