Crossing ID: WC_0330

NSWA Sturgeon River Watercourse Assessment

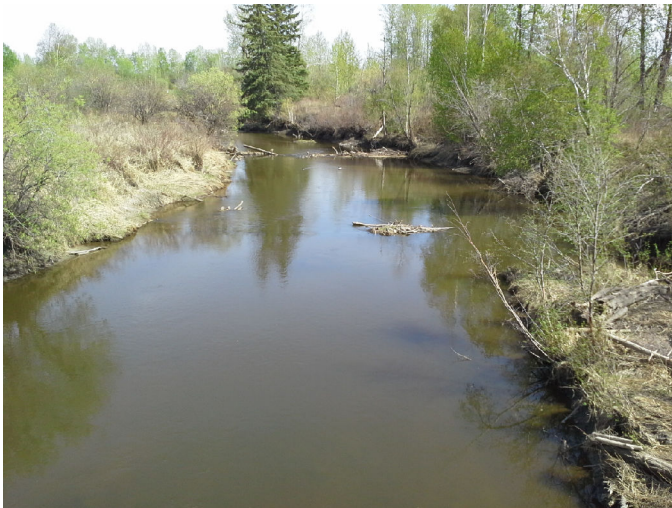
Photo No.: Photos-20180514-212500.jpg
Description: Downstream

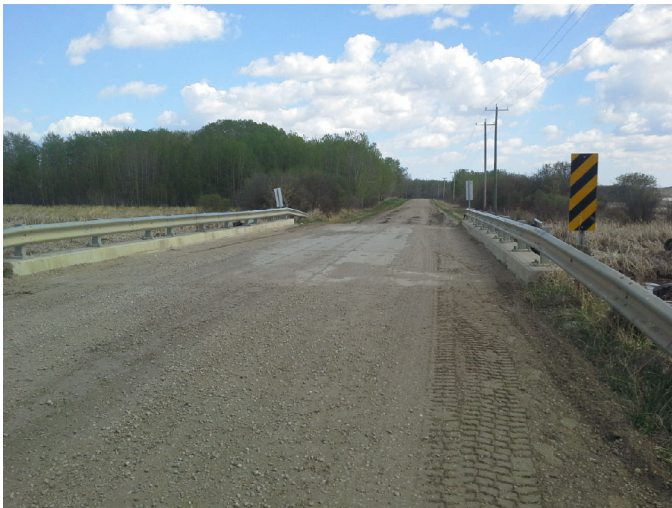
Photo No.: Photos-20180511-212849.jpg
Description: Deck

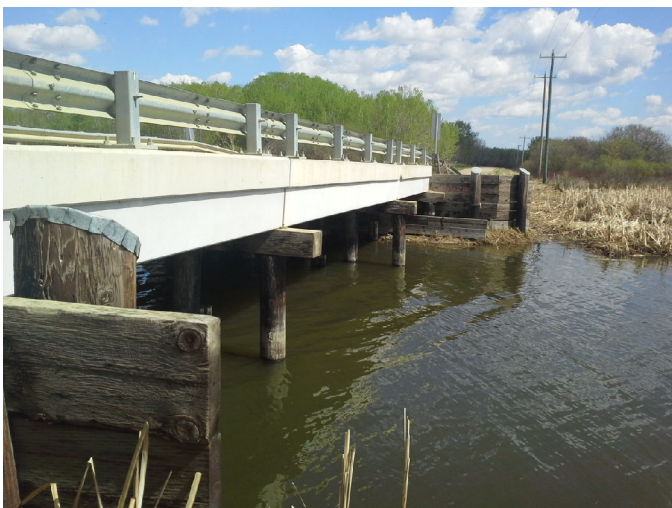
Photo No.: Photos-20180511-212930.jpg
Description: Inlet

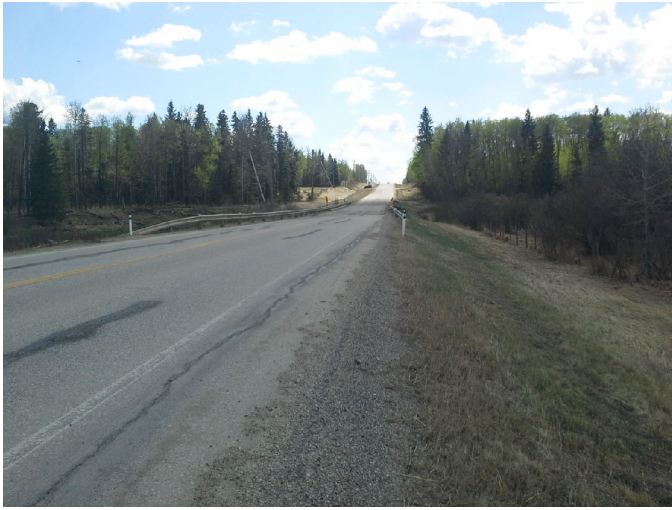
Photo No.: Photos-20180511-204314.jpg
Description: Deck

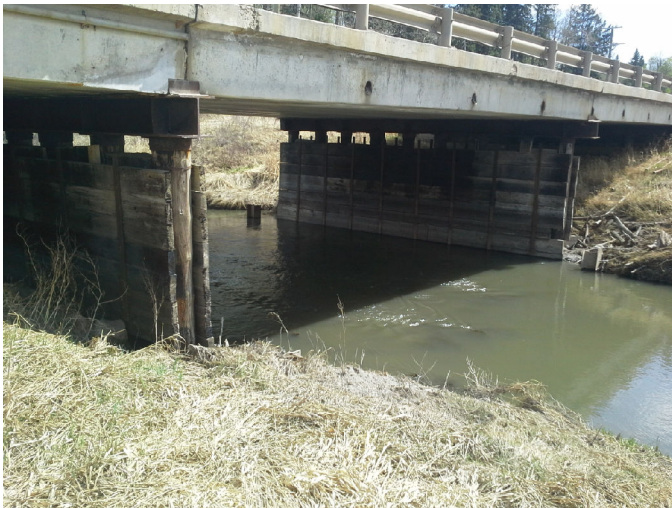
Photo No.: Photos-20180511-204529.jpg
Description: Inlet

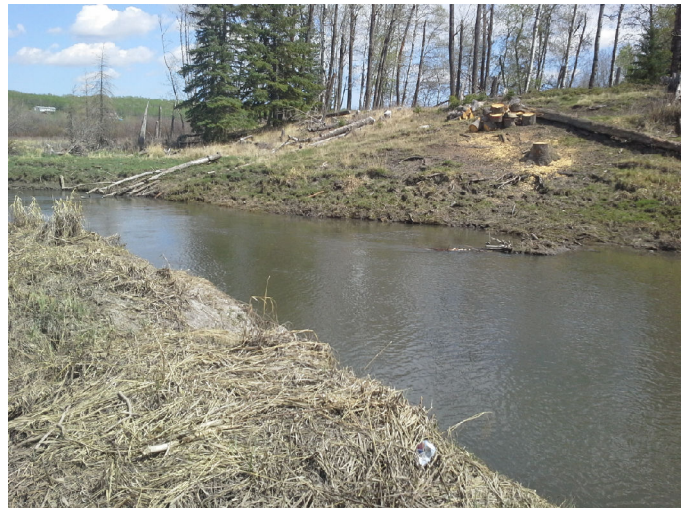
Photo No.: Photos-20180511-204623.jpg
Description: Downstream

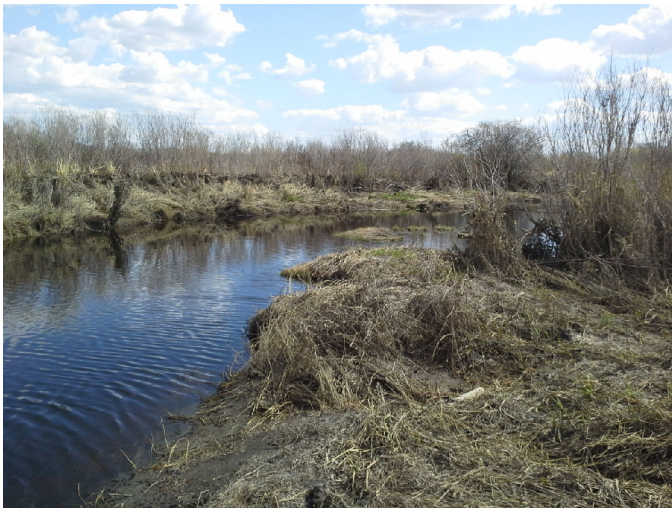
Photo No.: Photos-20180508-214000.jpg
Description: Downstream

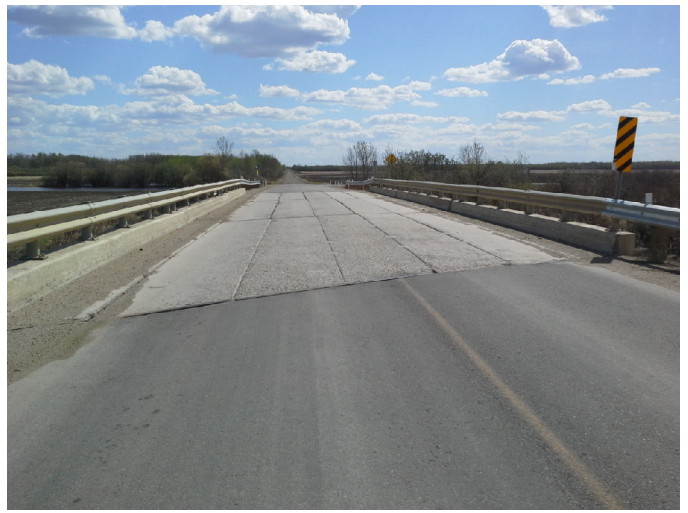
Photo No.: Photos-20180508-212500.jpg
Description: Deck

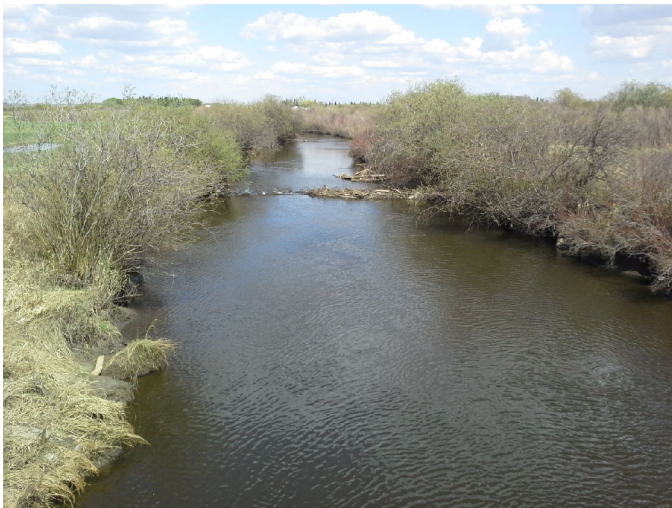
Photo No.: Photos-20180508-212520.jpg
Description: Downstream

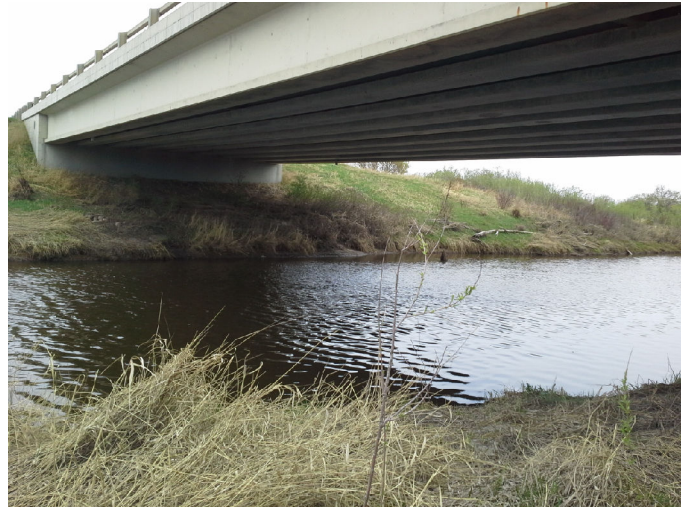
Photo No.: Photos-20180516-200102.jpg
Description: Inlet

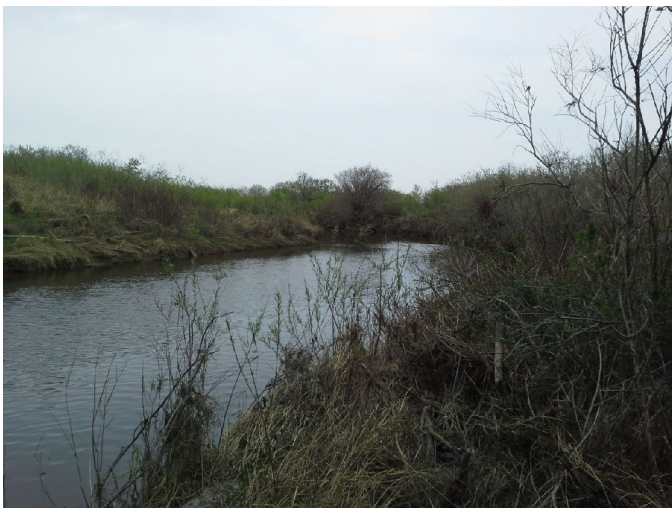
Photo No.: Photos-20180516-200142.jpg
Description: Downstream

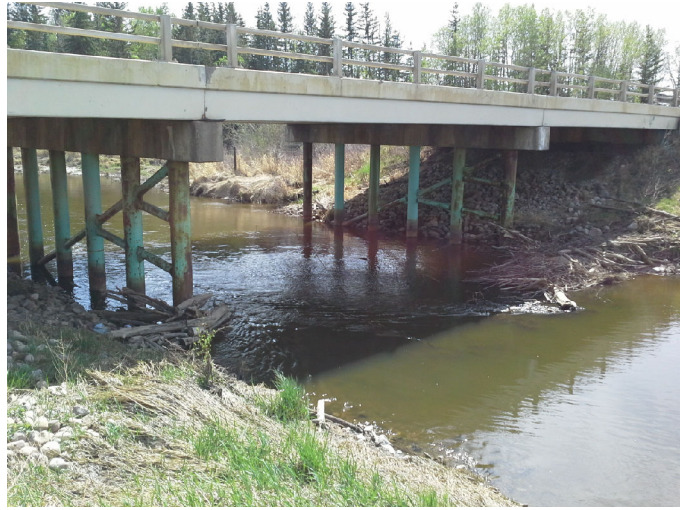
Photo No.: Photos-20180514-213844.jpg
Description: Inlet

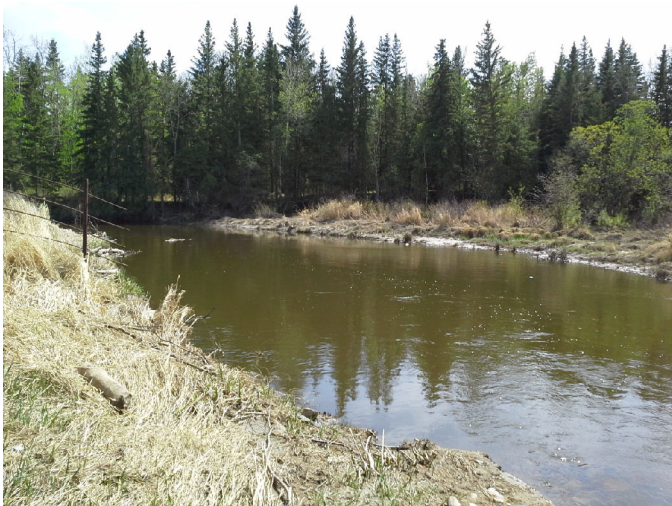
Photo No.: Photos-20180514-213929.jpg
Description: Downstream

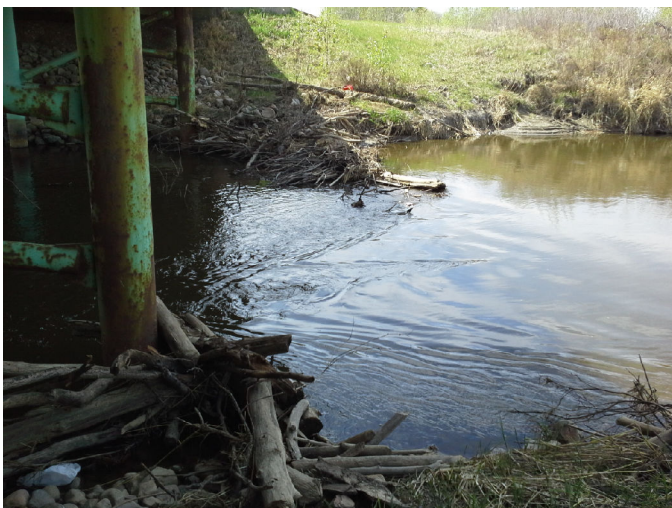
Comments: Build up of organic debris on abutment pilings.

Photo No.: Photos-20180514-214037.jpg
Description: Debris build up

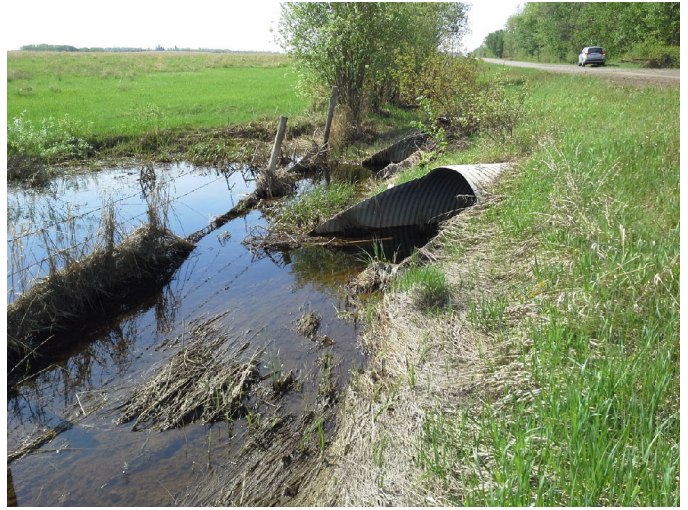
Photo No.: Photos-20180518-165658.jpg
Description: Inlet

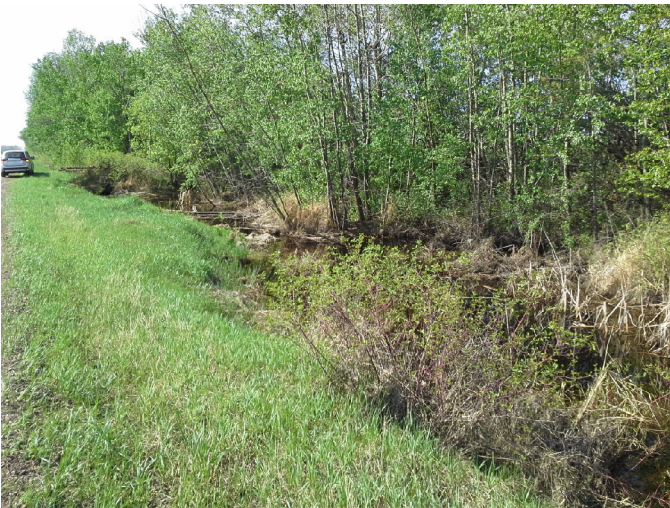
Photo No.: Photos-20180518-165751.jpg
Description: Downstream

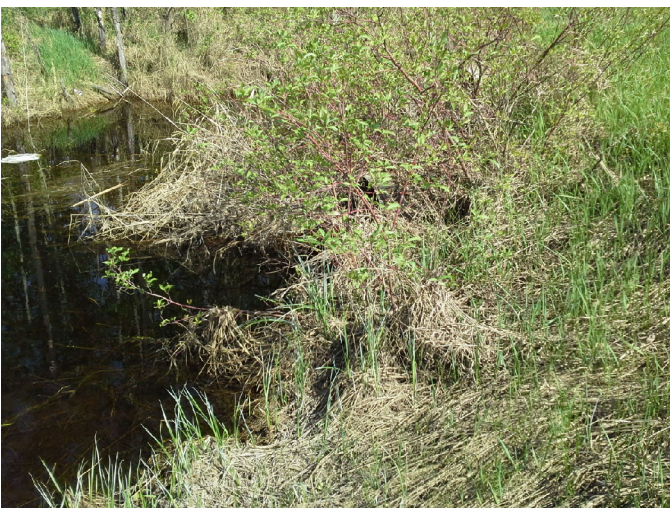
Photo No.: Photos-20180518-165830.jpg
Description: Culvert 2 - Outlet

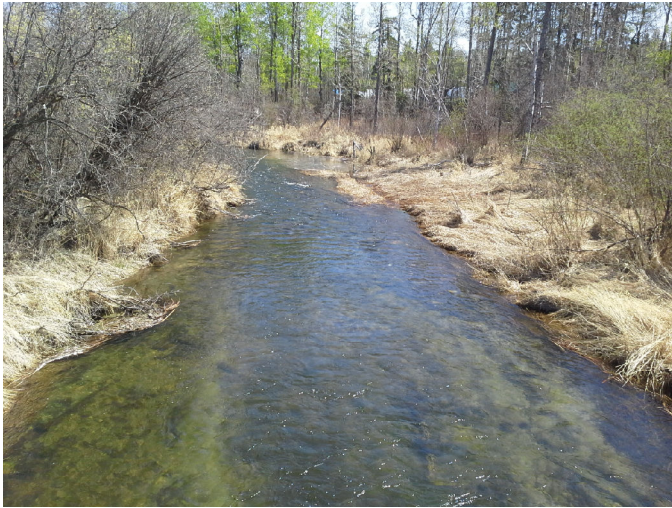
Photo No.: Photos-20180511-191217.jpg
Description: Downstream

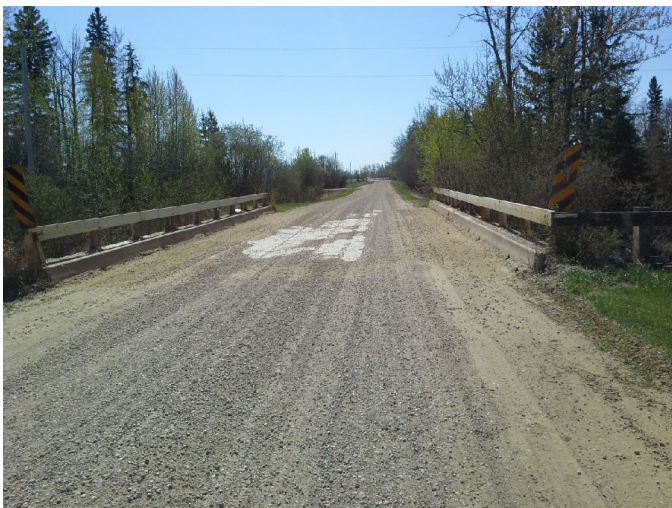
Photo No.: Photos-20180511-191249.jpg
Description: Deck

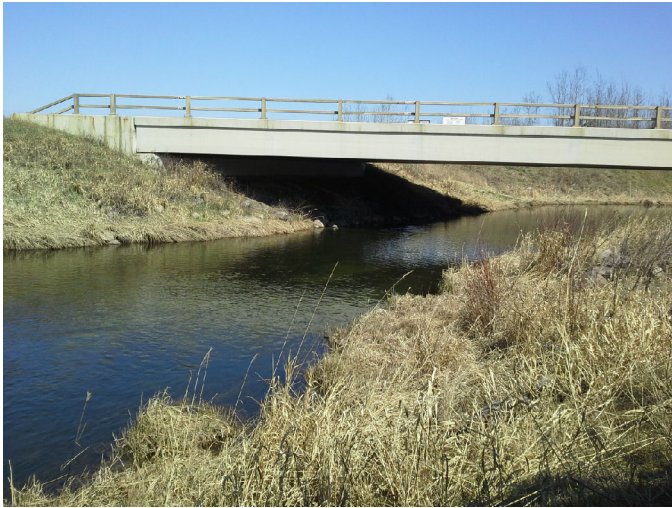
Photo No.: Photos-20180511-184919.jpg
Description: Inlet

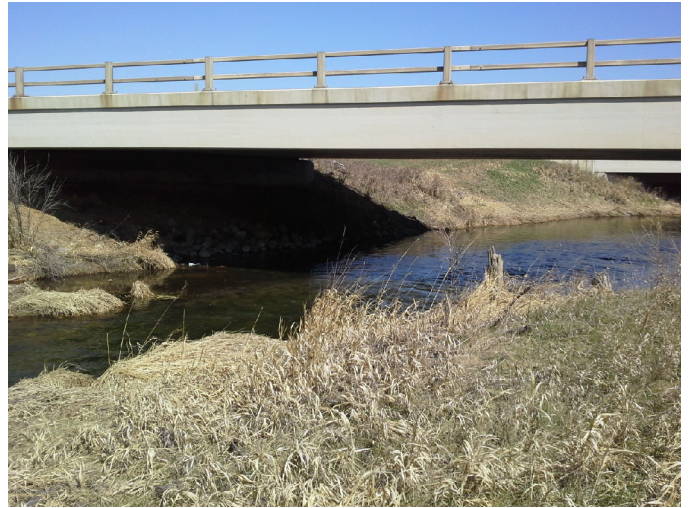
Structural Problems: Yes, damaged guardrail

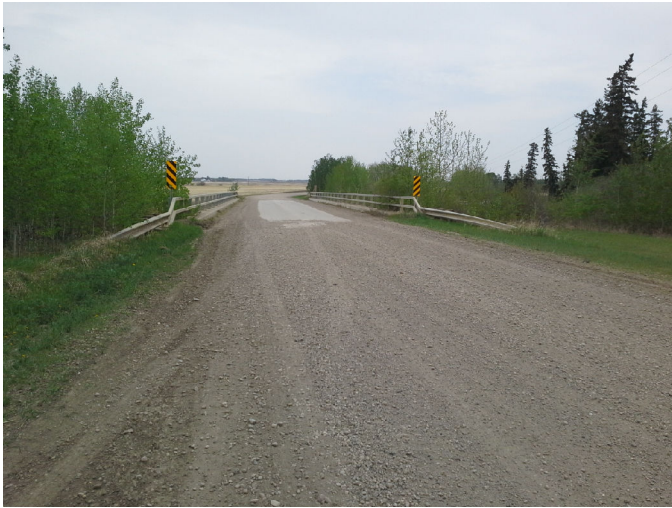
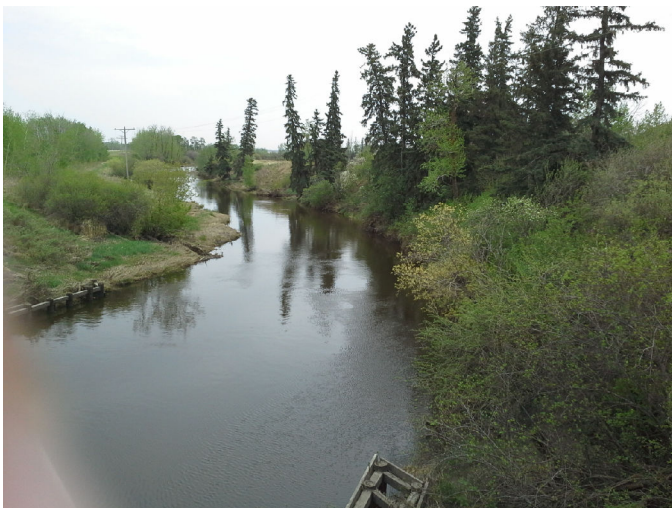
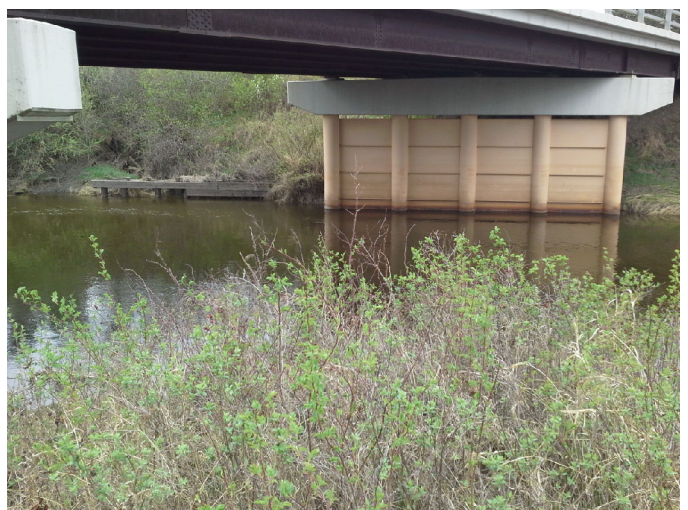
Comments: Area below walking path is grass vegetated. This could lead to erosional issues.

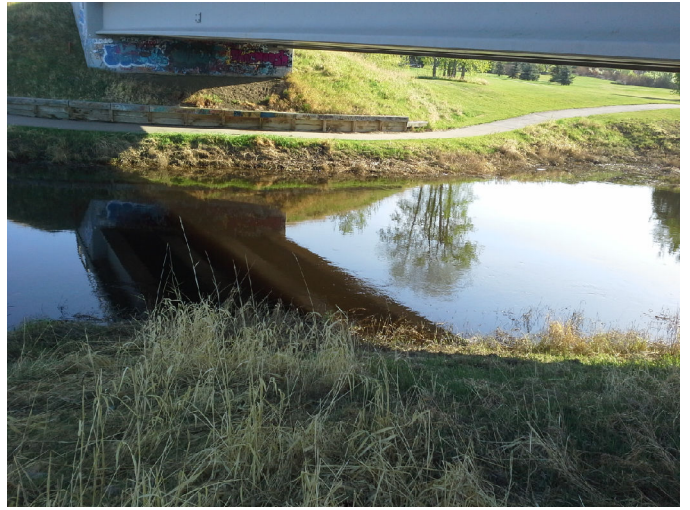
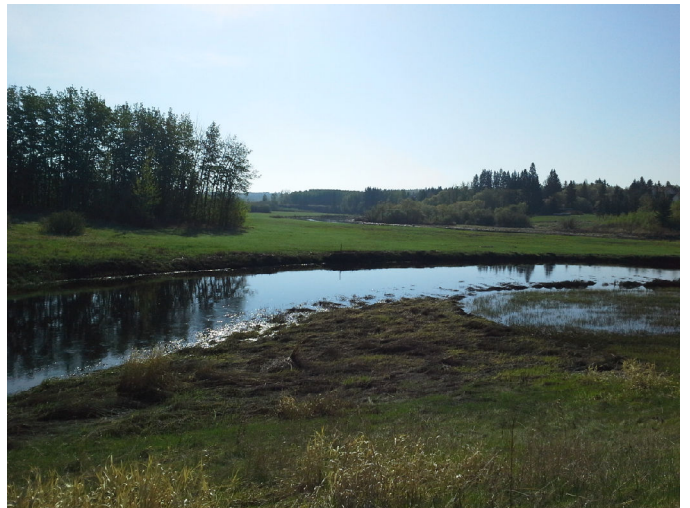
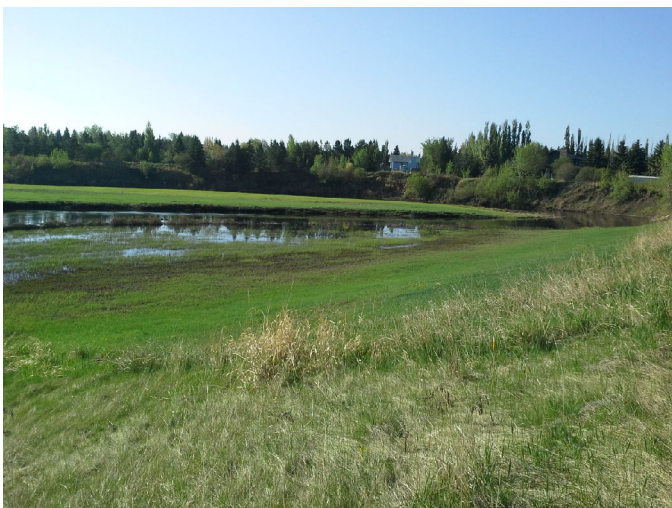
Comments: river and ice barges caused flooding across flood plain this past spring says landowner. old bridge abutments still in channel but lower than water level

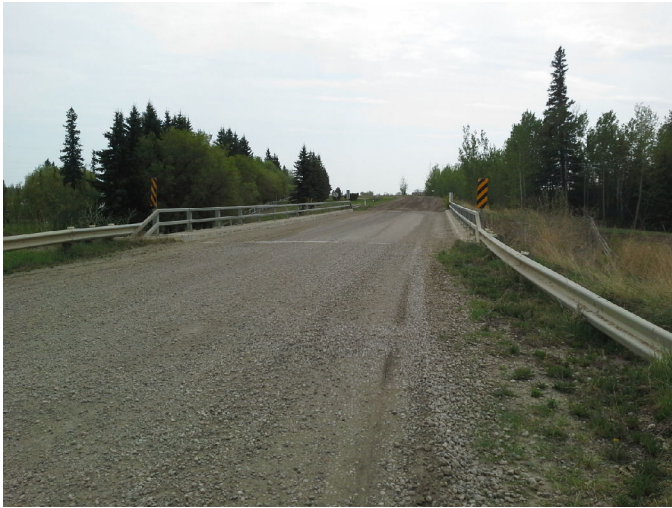
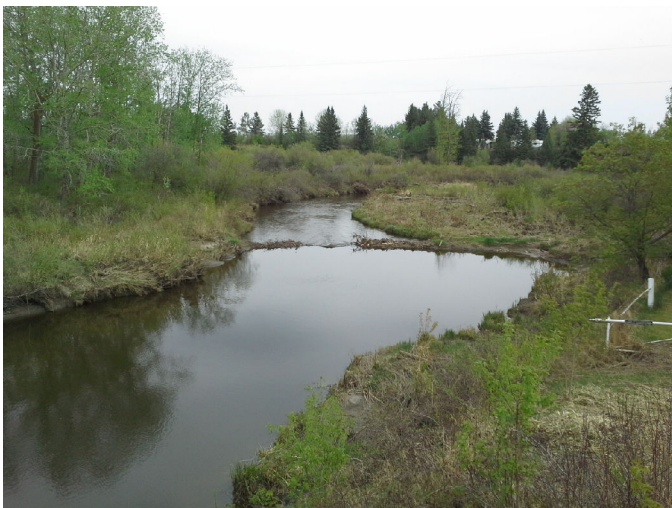
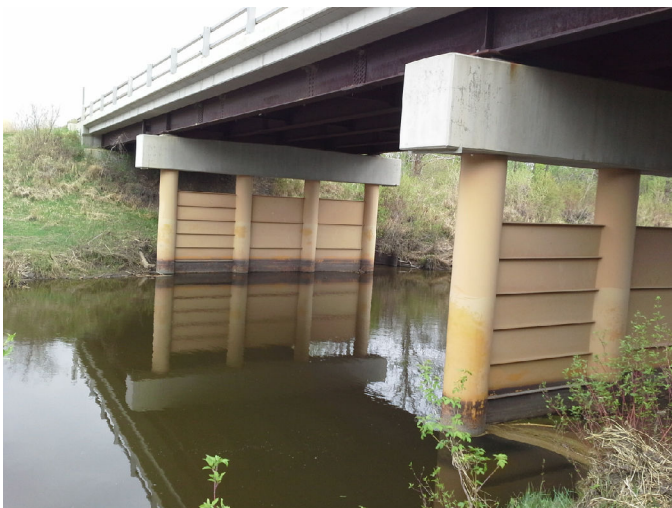
Comments: Stream converges at bridge from 2 different directions. Bridge is at stream capacity, unable to determine structural integrity. Some organic debris blockage.

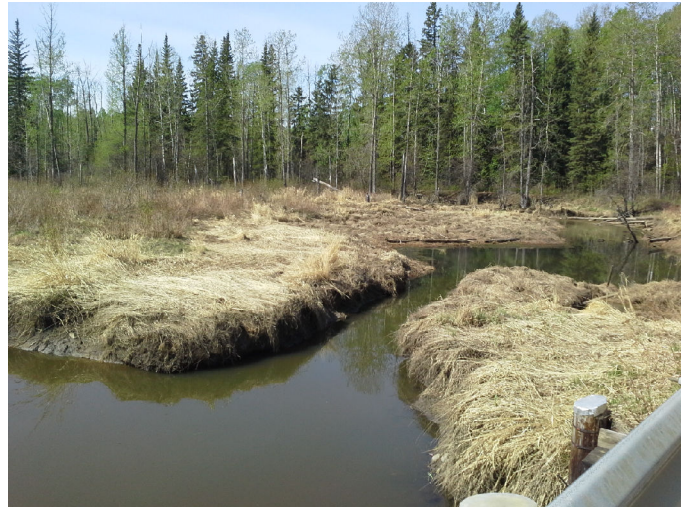
Photo No.: Photos-20180514-171153.jpg
Description: Upstream - Southwest

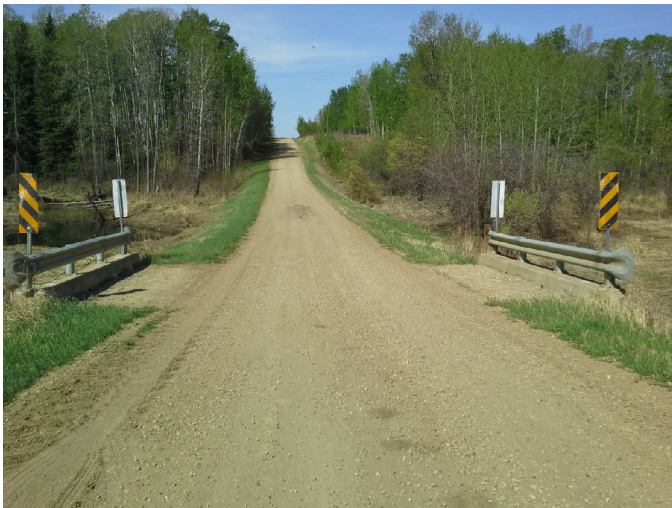
Photo No.: Photos-20180514-171213.jpg
Description: Deck

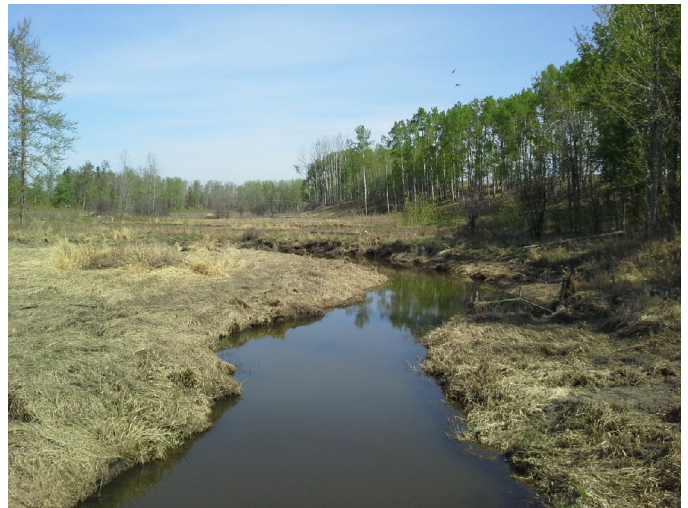
Photo No.: Photos-20180514-171231.jpg
Description: Downstream

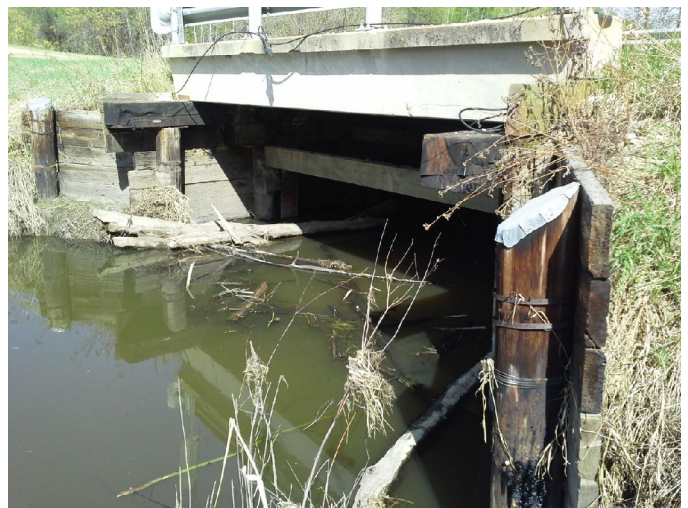
Photo No.: Photos-20180514-171424.jpg
Description: Inlet
