Crossing ID: WC_0330

NSWA Sturgeon River Watercourse Assessment

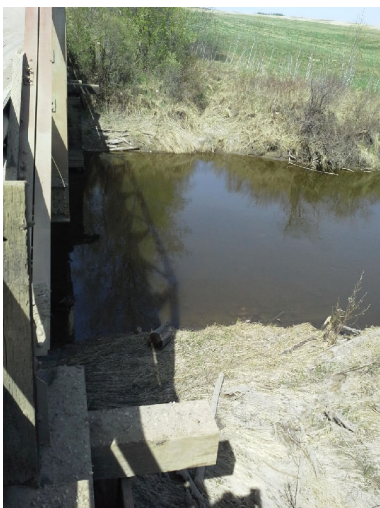
Photo No.: Photos-20180514-212625.jpg
Description: Outlet

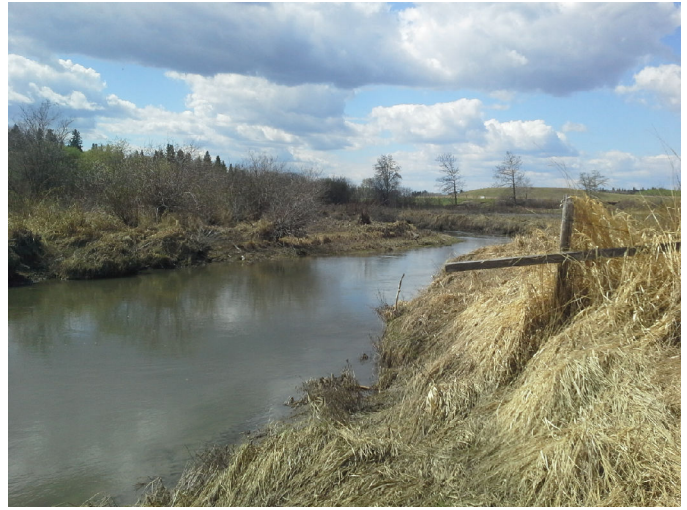
Photo No.: Photos-20180511-204517.jpg
Description: Upstream

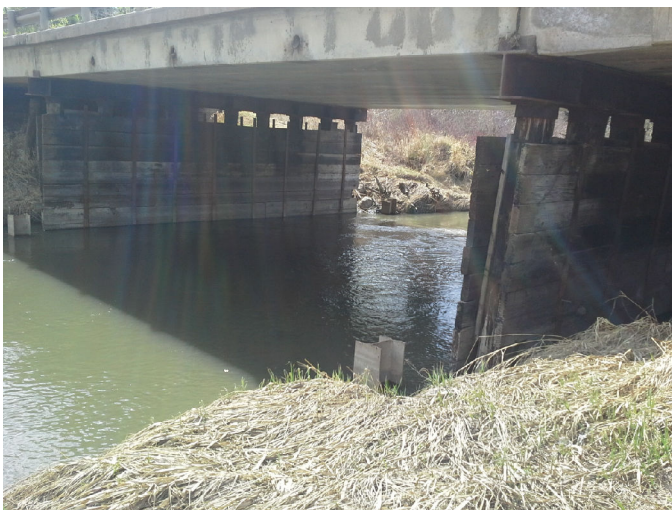
Photo No.: Photos-20180511-204650.jpg
Description: Outlet

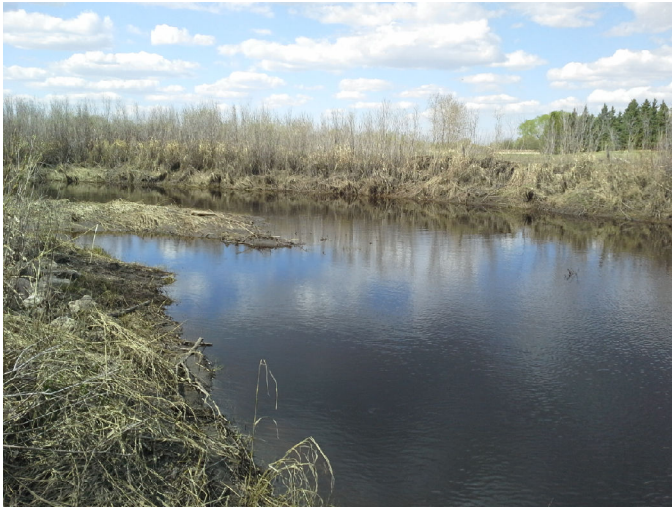
Photo No.: Photos-20180508-213850.jpg
Description: Upstream

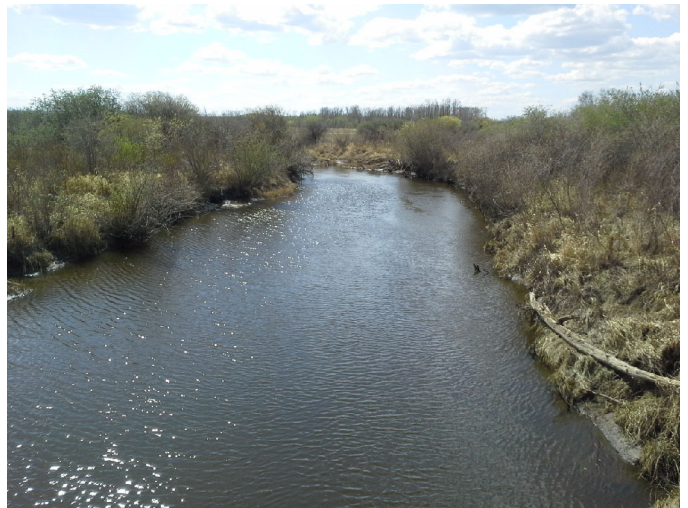
Photo No.: Photos-20180508-212537.jpg
Description: Upstream

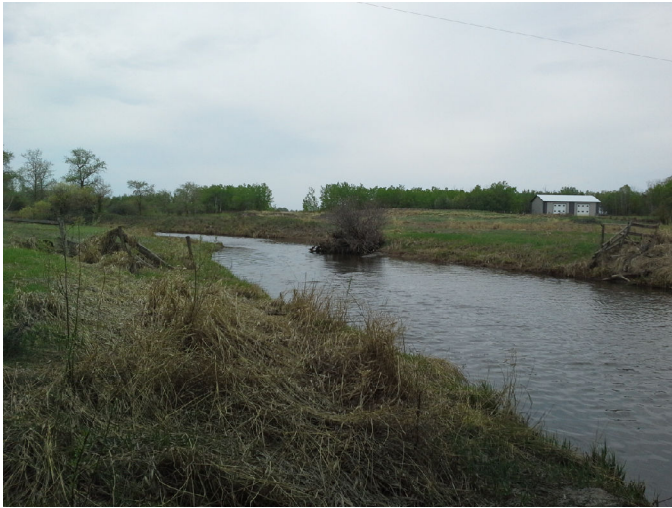
Photo No.: Photos-20180516-200042.jpg
Description: Upstream

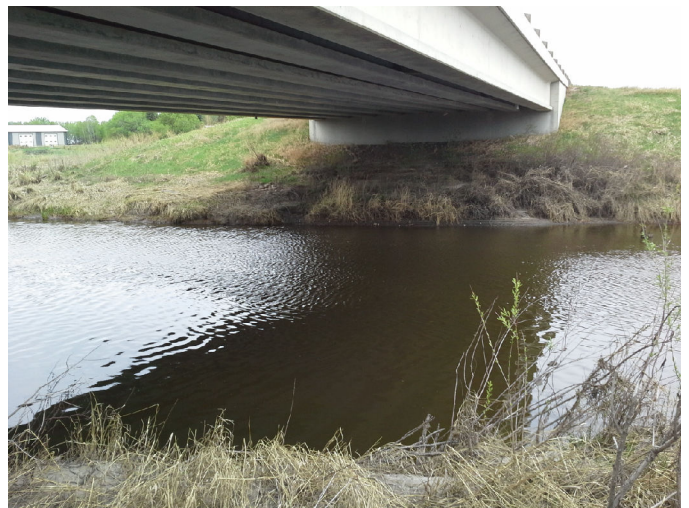
Photo No.: Photos-20180516-200201.jpg
Description: Outlet

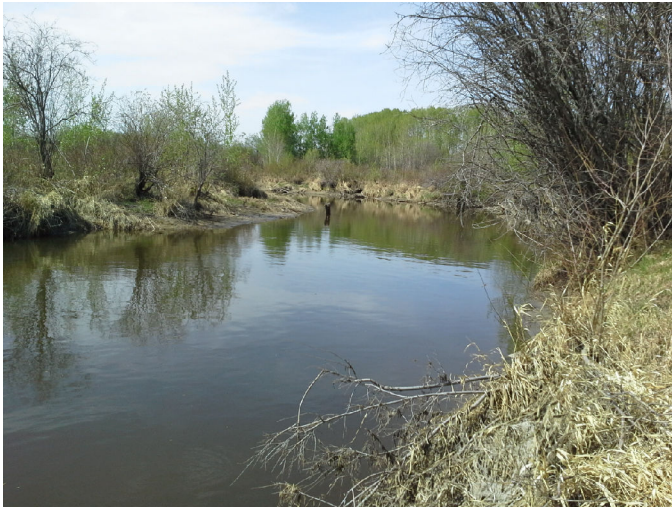
Photo No.: Photos-20180514-213825.jpg
Description: Upstream

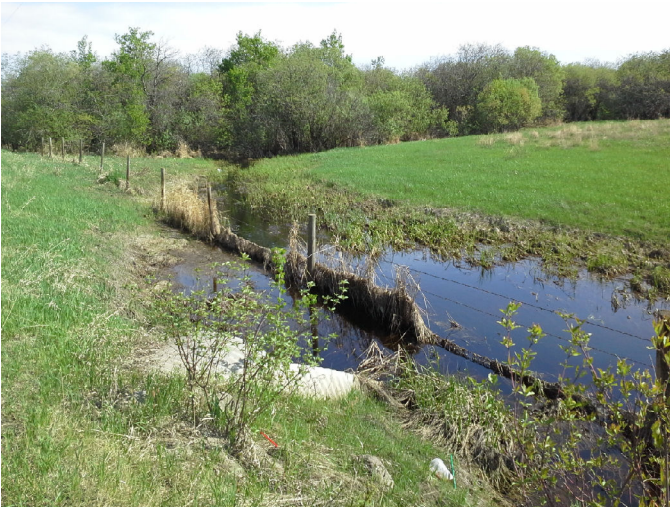
Photo No.: Photos-20180518-165629.jpg
Description: Upstream

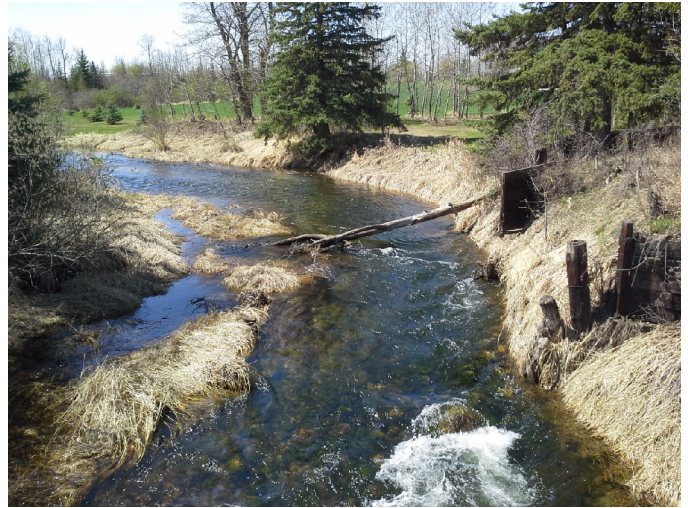
Photo No.: Photos-20180511-191228.jpg
Description: Upstream

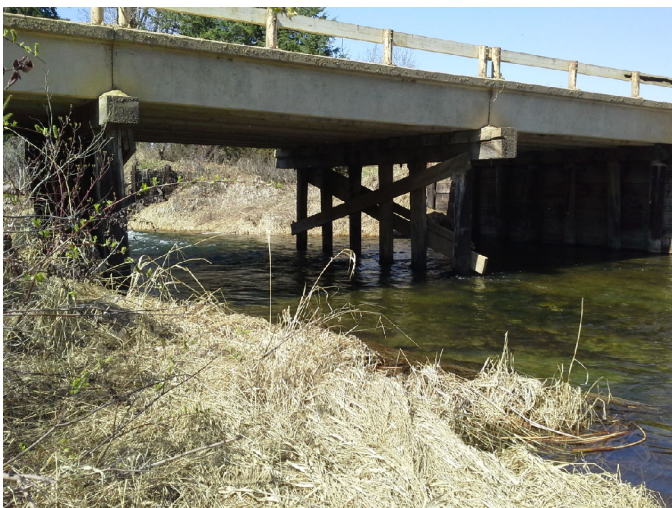
Photo No.: Photos-20180511-191426.jpg
Description: Outlet

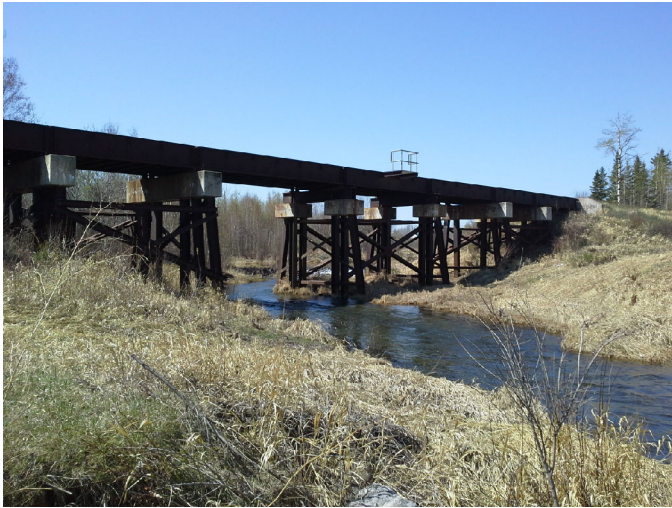
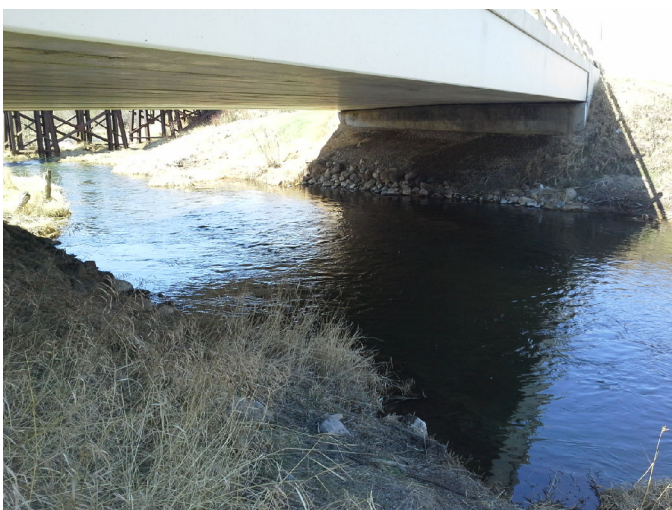
Structural Problems: Yes, damaged guardrail

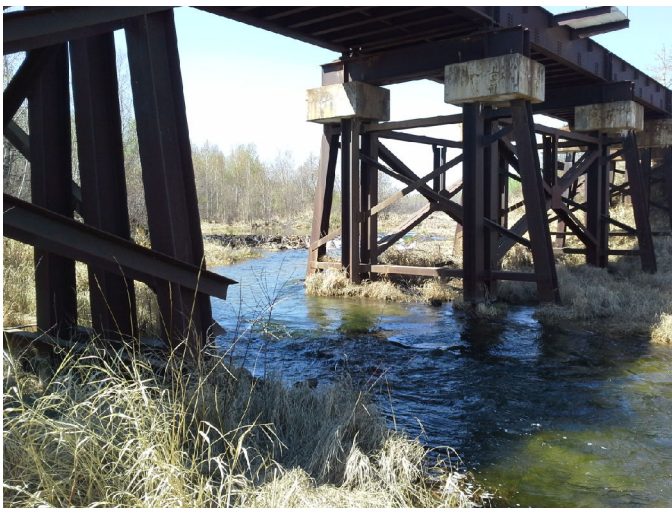
Photo No.: Photos-20180511-184027.jpg
Description: Beaver dam upstream

Noted to find 2 dead adult foxes near waters edge

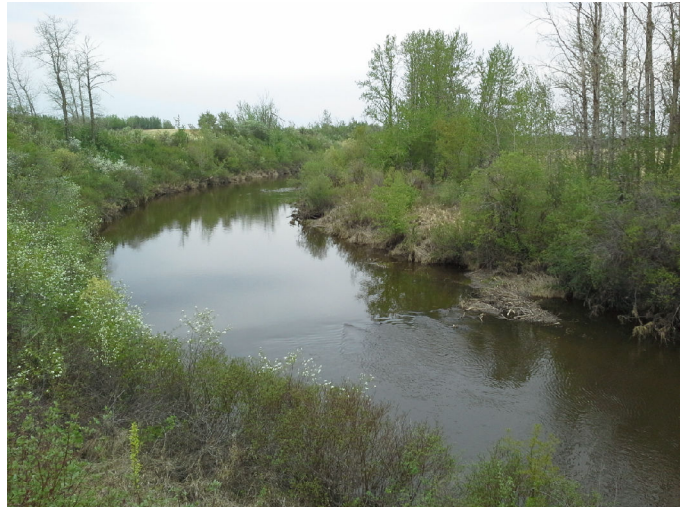
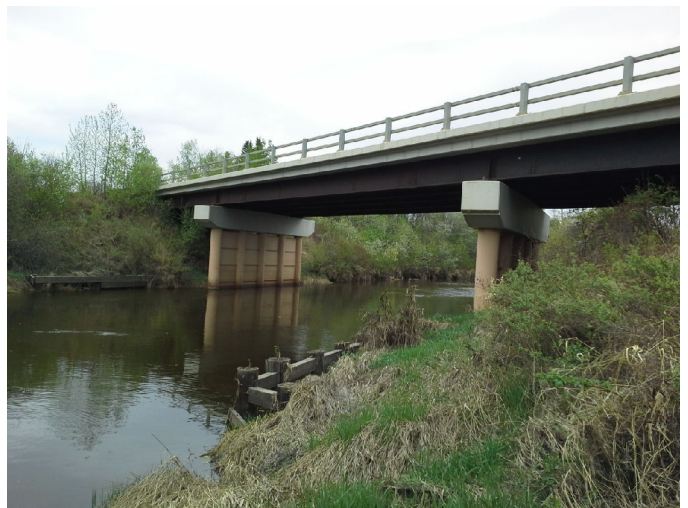
Comments: Area below walking path is grass vegetated. This could lead to erosional issues.

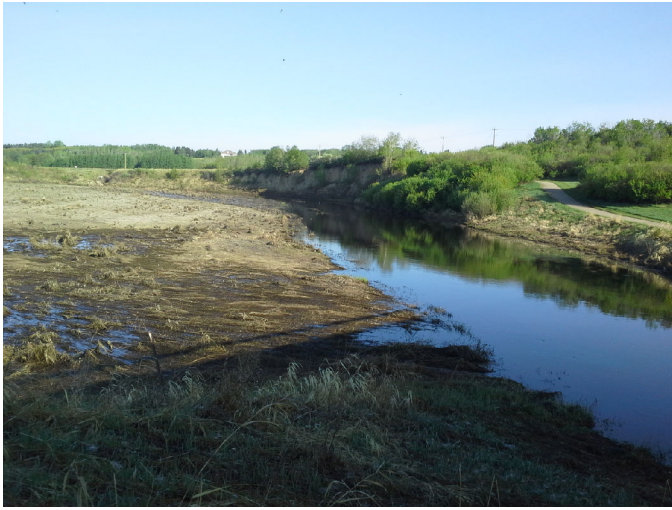
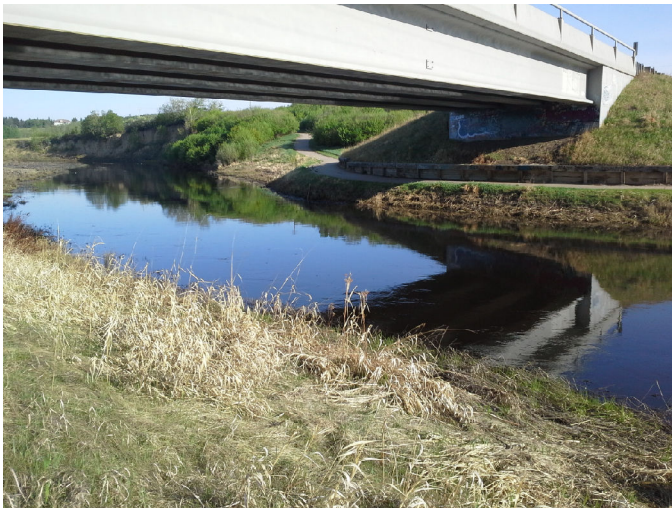
Comments: river and ice barges caused flooding across flood plain this past spring says landowner. old bridge abutments still in channel but lower than water level

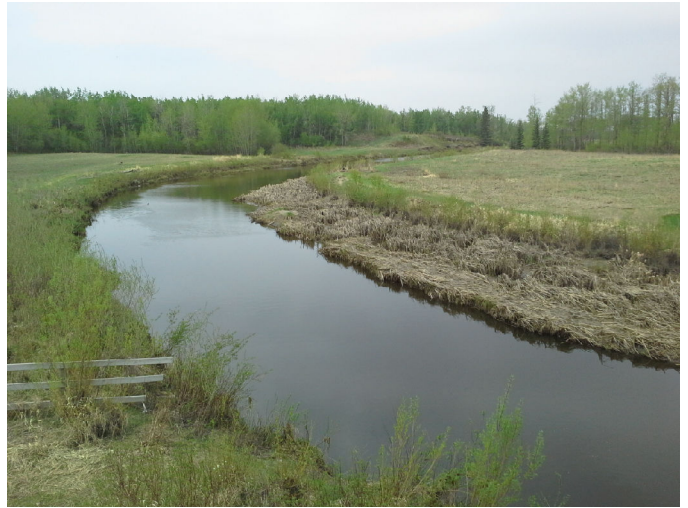
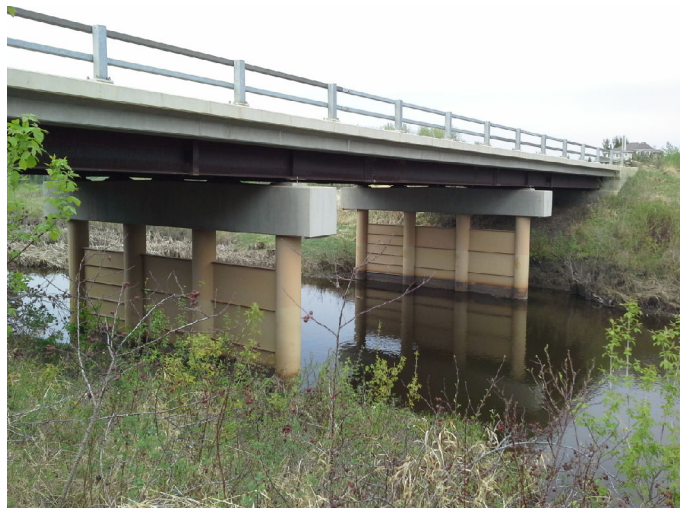
Comments: Stream converges at bridge from 2 different directions. Bridge is at stream capacity, unable to determine structural integrity. Some organic debris blockage.

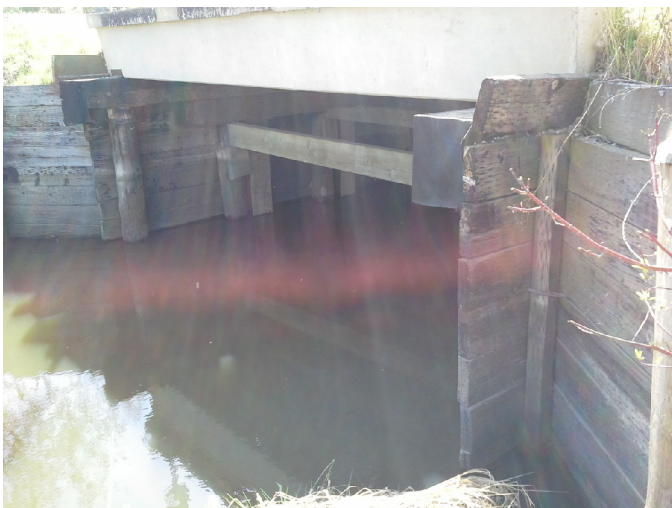
Photo No.: Photos-20180514-171311.jpg
Description: Outlet
